LuxaCrown pediatric case documentation

Dr. Richard Bernstein

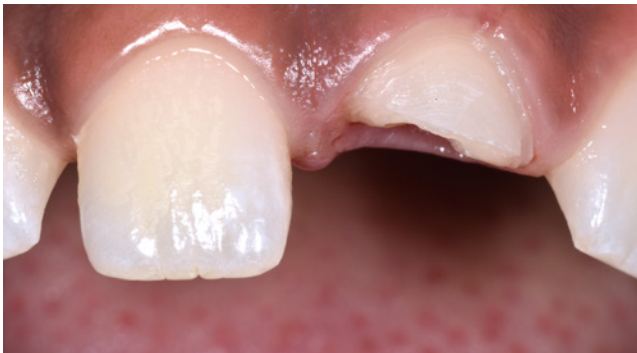
A ten year girl was referred to my office from a local Pediatric dentist. The girl presented with an extensive fracture of the left central incisor, 21. Part of the fracture extended down the lingual subgingival to bone level and the pulpal chamber was exposed. Consulting with the endodontist and the parents, it was decided to save the tooth with root canal treatment followed by a crown build-up. The child had much spacing and would need orthodontic treatment in the future. The introduction of LuxaCrown made this treatment more "doable" for the parents, child and restoring dentist.

Fig. 1: Fractured left maxillary central incisor (21) on a ten year old girl.

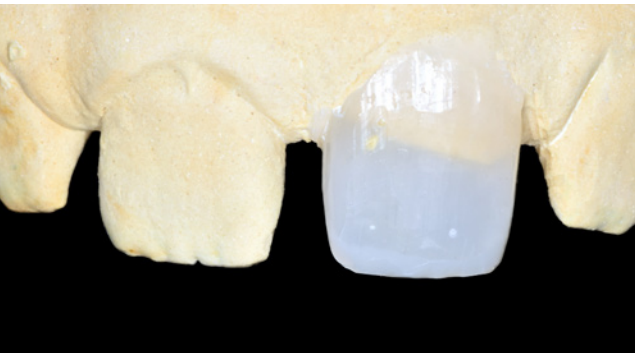
Fig. 2: Ideal mock-up of left central incisor (mirror image of 11).

- Consulted with the endodontist first step was to treat with an RCT.
- Impression made for lab fabrication of all porcelain post/core (empress)
- Build-up or mock-up of 21 as a mirror image of 11 on the hard model
- Bonded the post/core into the root of 21 using LuxaCore Z
- Prepped existing tooth to gingival level with chamfer finish line

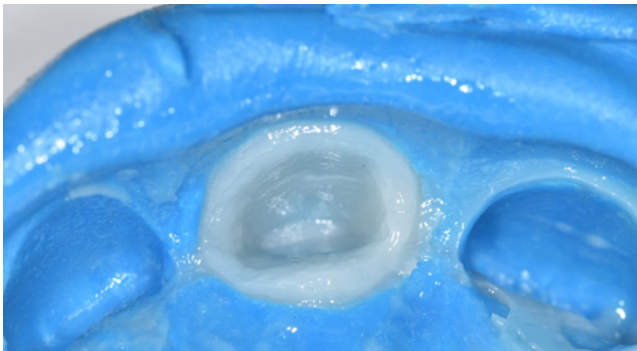
Fig. 3: Luxacrown fabrication using polyvinyl impression of mock-up. (Honigum).

With polyvinyl matrix (Honigum) used for the mock-up, LuxaCrown material (shade A1) applied to the impression, and then placed in the mouth over the dentition for one minute. It was then removed and the LuxaCrown was trimmed, and polished. Used various ET burs, polishing discs and rubber points. Same procedure as if it were a composite restoration.

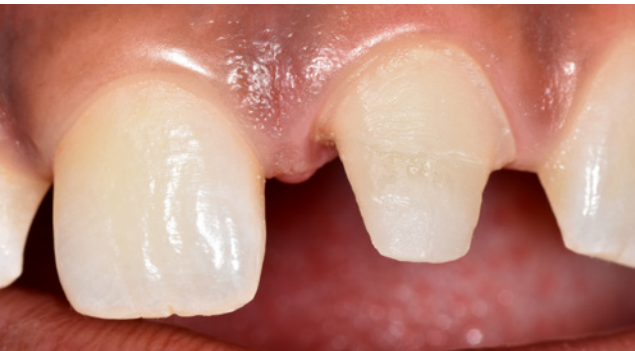
Fig. 4: Prepped tooth after all-porcelain post/core was bonded into post hole.

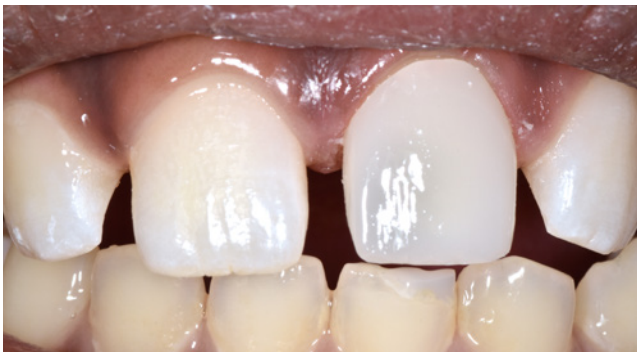
Fig. 5: LuxaCrown bonded in place, margins finished and given a final polish and glaze.

The LuxaCrown was bonded over the tooth with Theracem (Bisco). The margins were finished, trimmed and smoothed and given a final polish. Luxaglaze was placed and then light cured.

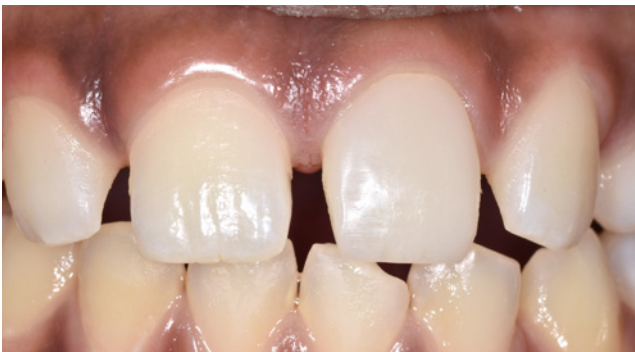
At the one month follow up the LuxaCrown showed good performance in fit, durability and esthetics.

Fig. 6: One month follow-up.
