Immediate restoration of a complete crown fracture in a central incisor

Dr. Giulio Pavolucci

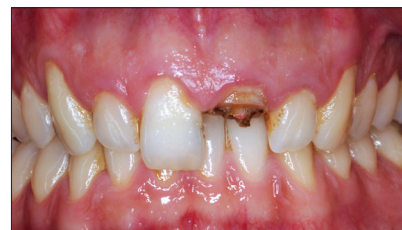
The patient, a 30-year-old male, presented to our office as an emergency case after losing his upper left central incisor (Fig. 1). His usual dentist was closed for summer vacation and therefore he came to our office without an appointment to ask for help.

Fig. 1: Initial situation

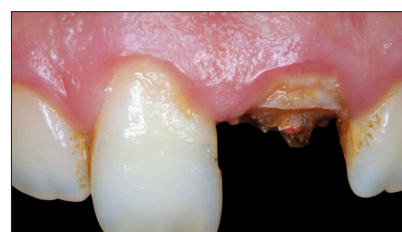
Upon the initial examination, it was visibly noticeable that the patient was not accustomed to visiting his dental office for regular cleanings. Plaque, calculus, severe gingivitis and a few caries lesions were easily visible during the visual examination (Fig. 2).

Fig. 2: Extensive caries visible on stump

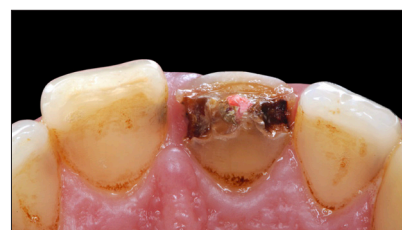
It is evident that the fracture was caused as a result of the caries. The tooth underwent a root canal some years earlier; however, the restoration is now deeply infiltrated by caries. From a palatal view, a class III cavity was also visible on the mesial side of tooth 11 (Fig. 3).

Fig. 3: Palatal view

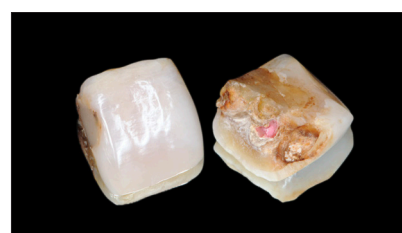
The crown was completely infiltrated by caries and is thus no longer useful (Fig. 4).

Fig. 4: Fractured crown

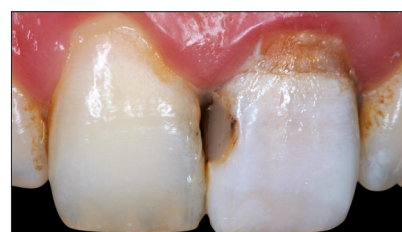
Fig. 5: Fractured crown used as mock-up to fabricate impression matrix

Despite this, there was actually a way to use the old crown. The crown could be put back into place using some flowable composite, which could be used to create a “homemade” mock-up of a temporary crown (Fig. 5).

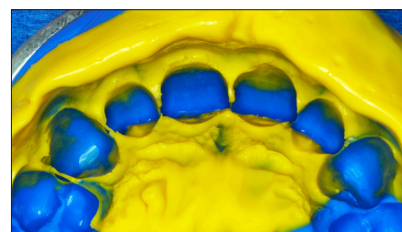
Fig. 6: Honigum Pro impression matrix

Precision and stability were needed in order to create a good shape of the temporary crown, as well as to save time for finishing. For this purpose, we used a high precision silicone impression material in two different viscosities (Honigum Pro Light and Honigum Pro Heavy, DMG) (Fig. 6).

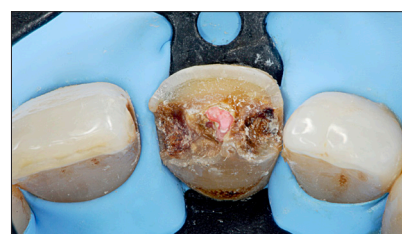
Fig. 7: Palatal view after isolation with rubber dam

It is typically standard procedure to clean the mouth of the patient prior to treatment; however, since this was an emergency case, and since there was a risk of difficult-to-control bleeding, we decided to proceed without cleaning the neighboring teeth (Fig. 7).

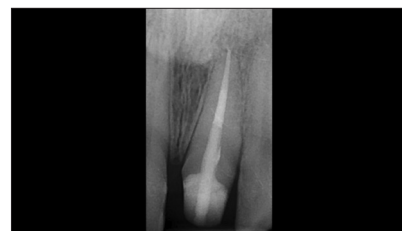
Fig. 8: Radiograph after root canal treatment

The caries and old filling material were completely removed. The root canal treatment was subsequently completed (Fig. 8).

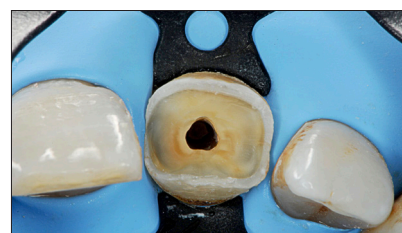
Fig. 9: Root canal after preparation

The dowel space was prepared, paying special attention to remove only the gutta-percha, without cutting away sound dentin (Fig. 9).

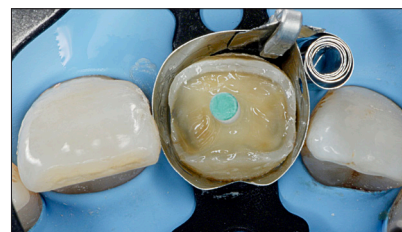
Fig. 10: Luting of LuxaPost

A universal adhesive (LuxaBond Universal, DMG) was applied to the root canal, preparation area and the fiber post in self-etch and dual-cure mode. The post was then cemented using a dual-cure resin cement (PermaCem Universal, DMG) (Fig. 10).

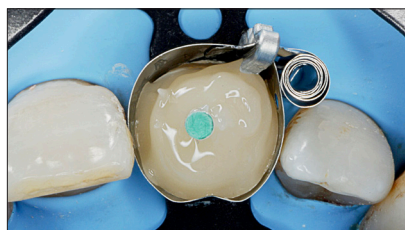
Fig. 11: Core build-up with LuxaCore Z Dual

The core was easily restored using a dual cure material (LuxaCore Z Dual, DMG) with the help of a circumferential matrix (Fig. 11).

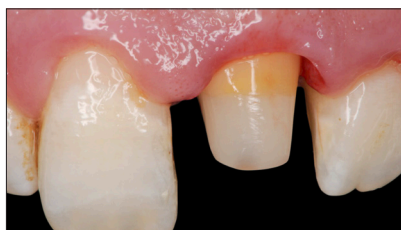
Fig. 12: Core build-up after preparation

The abutment was prepared with a vertical finishing area (Fig. 12).

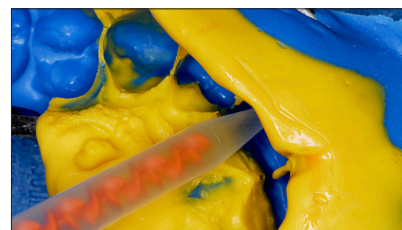
Fig. 13: Dispensing of LuxaCrown into Honigum Pro silicone matrix

Based on this, a self-cure material designed for semi-permanent restorations was dispensed (LuxaCrown, DMG) into the prepared impression (Fig. 13). The impression was placed back into the mouth.

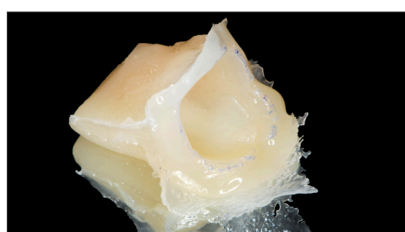
Fig. 14: Semi-permanent crown with highlighted margins

After the curing time was complete, the crown was removed from the impression. Intracul-
marginal margins were highlighted with a pencil (Fig. 14).

The concavity between the blue line and the outer margin of the crown was filled with a flowable composite. The crown was finished and polished.

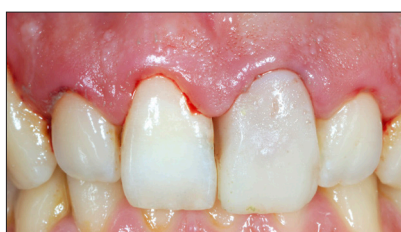
Fig. 15: Fitting of the semi-permanent crown

At this moment it was possible to use the ultrasonic scaler to remove some calculus without worrying about bleeding. The semi-permanent crown was cemented (Fig. 15).

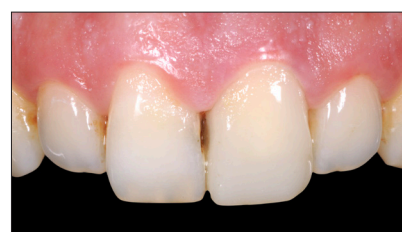
Fig. 16: Final restoration

Two weeks after the semi-permanent crown cementation (Fig. 16), the gums appear to be healthier. The patient has no pain and is completely satisfied with the solution.

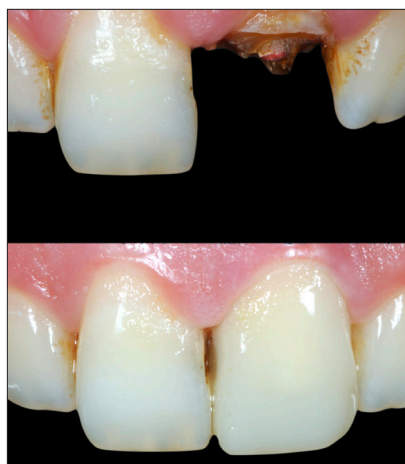
Fig. 17: Initial situation vs. situation after emergency treatment
