## Case report: The infiltration technique for MIH using abrasives

Dr. Erik-Jan Muts

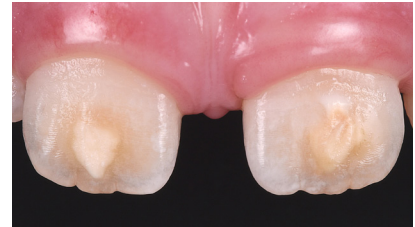
Fig. 1: Lesions on both 11 and 21 showing yellow and white lesions.

Freek (8) was referred for discoloration on his two central incisors: 11 and 21. Due to hypomineralisation of the first permanent molars, Molar Incisor Hypomineralisation (MIH) was diagnosed as the cause for the enamel defects in the central incisors. The hypomineralisation extended completely to the surface of the enamel. We know that in the case of MIH, hypomineralisation extends all the way to the dentin-enamel junction (DEJ); therefore the lesions were as thick as the enamel in this case. (Fig. 1, 2)

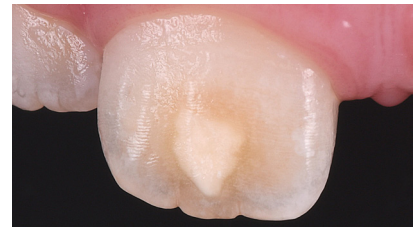
Fig. 2: Close-up of 11.

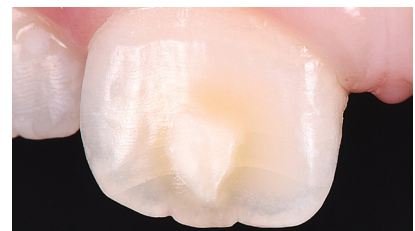
Fig. 3: Situation after 5 days of bleaching with 10% carbamide peroxide.

In order to get a better colour for the hypomineralisations, bleaching was carried out with 10% carbamide peroxide for 5 days for only 2 hours a day. Carbamide peroxide breaks down in contact with water into hydrogen peroxide and urea. Hydrogen peroxide is responsible for the oxidation of the double bonds of the chromogens and causes the bleaching effect. An extra very important effect of carbamide peroxide is the deproteinising effect of the urea. This ensures a good infiltration procedure later on. After 5 days of bleaching the result was evaluated and another 5 days of bleaching was advised. The result after 10 days was satisfactory and after a 4-week break the infiltration procedure was scheduled, in order to make sure that the oxidative stress was no longer present and good adhesion was possible. (Fig. 3, 4)

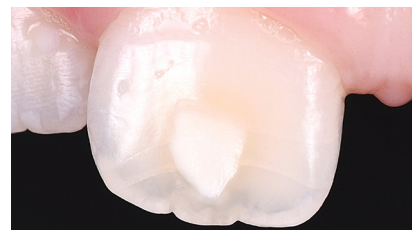
Fig. 4: Situation after 10 days of bleaching with 10% carbamide peroxide.

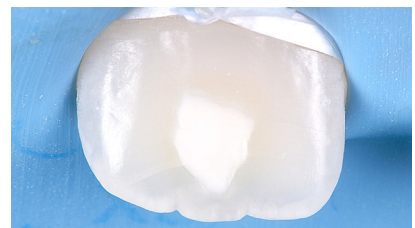
Fig. 5: Rubber dam isolation with the help of floss ligatures.

After topical anaesthesia for the gingiva full rubber dam isolation was carried out. Because the lesion extended to the enamel surface we started using a micro-abrasive slurry with pumice and 35% phosphoric acid, mixed one to one. A special rubber cup with an internal bristle was used and the slurry was applied for 60 seconds each application. During this application about 10-20um of sound enamel was expected to be removed depending on the force applied. Since the superficial enamel is already hypomineralised we expect the abrasiveness to be a lot higher. (Fig. 5, 6)

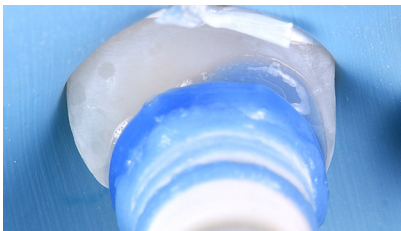
Fig. 6: Micro-abrasion with a mixture of phosphoric acid and pumice.

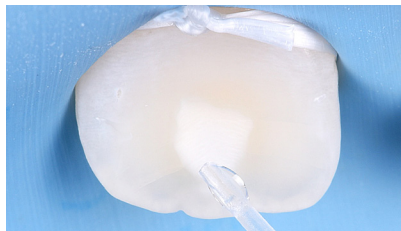
Fig. 7: Applying ethanol with the special tip.

After every application we rinsed thoroughly with water and after four applications we checked the permeability with ethanol. There was already pretty good permeability, but still not good enough. When applying ethanol it is important to let it evaporate in order to give the liquid sufficient time to show the full infiltration capacity. (Fig. 7, 8)

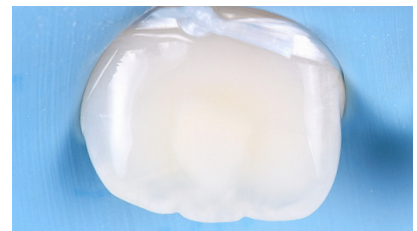
Fig. 8: Situation after 20 seconds the ethanol now shows the full infiltration capacity.

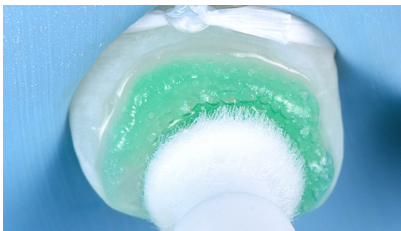
Fig. 9: Application of hydrochloric acid for 120 seconds.

Since more permeability was required 2 more applications of 15% HCl were carried out for 120 seconds. With each application, approximately 40um of sound enamel was removed, but it must be kept in mind that hypomineralised enamel will be more aggressively removed by hydrochloric acid. After the second session ethanol application showed full permeability so infiltration could be carried out. (Fig. 9, 10)

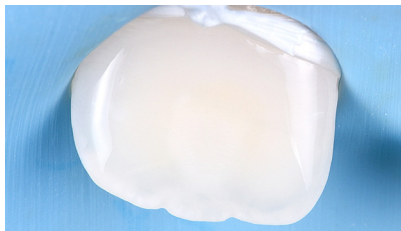
Fig. 10: Ethanol shows full permeability, ready for infiltration.

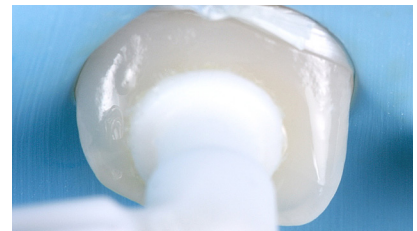
Fig. 11: Application of the infiltrant, the infiltrant was re-applied every 5 minutes.

Infiltration was carried out for about 15 minutes in order to achieve the best result possible. After 10 minutes there were still a few non-infiltrated areas observed with the microscope. Infiltration is carried out in low light conditions, to prevent premature setting of the infiltrant. When infiltration is completed the lesion is light cured for 40 seconds. (Fig. 11, 12)

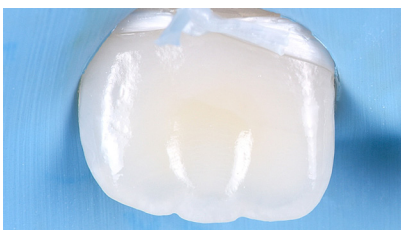
Fig. 12: Result immediately after light curing.

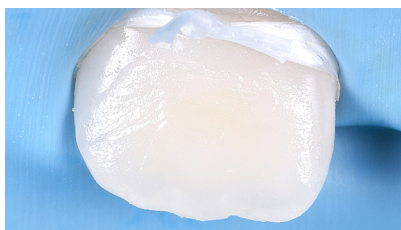
Fig. 13: Restoration of the missing enamel with composite resin.

In order to restore the shape and texture of both teeth, the application of composite resin was required. For optimal adhesion the infiltrated enamel was air-abraded very shortly, etched with 35% phosphoric acid and bonded with a total-etch system. After light cure (20 sec), composite was applied and after a further light cure (40 sec) the restoration was finished, polished and cured again with glycerine gel. (Fig. 13, 14)

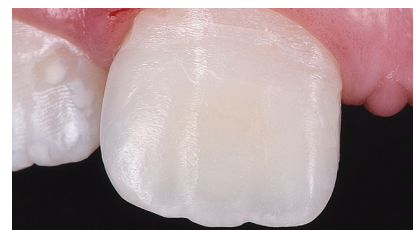
Fig. 14: After finishing and polishing.

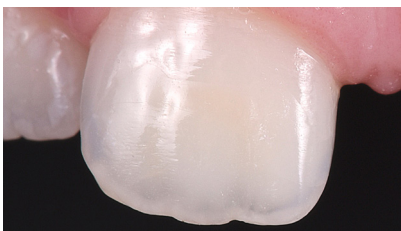
Fig. 15: Final result of 11 (close-up).

After two weeks we evaluated the final result. Both the patient and his parents were very pleased with the final result. When the hypomineralisation extends to the enamel surface it is not always necessary to be very aggressive with the micro-abrasion. In this case we used a mild abrasive paste in order to be as minimally invasive as possible. (Fig. 15, 16)

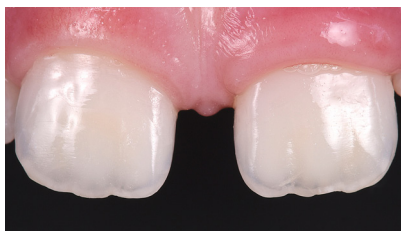
Fig. 16: Final result after infiltration of 11 and 21.
