Case report: Treatment of traumatic hypomineralisation with a combination of infiltration and restoration

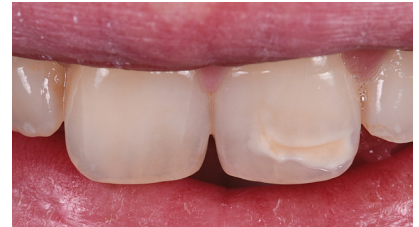
Fig. 1: Extra-oral view of enamel hypomineralisation on tooth 21.

Katherina (28) was referred to my practice by a colleague for the treatment of white and yellow discoloration on tooth 21. Since this was the only hypomineralisation present in Katherina's practically sound dentition, the enamel lesion was diagnosed as traumatic hypomineralisation. (Fig. 1, 2)

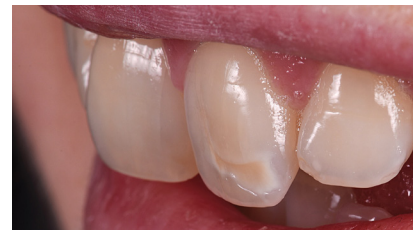
Fig. 2: Photo from an oblique angle shows disruptions of the buccal enamel surface of tooth 21.

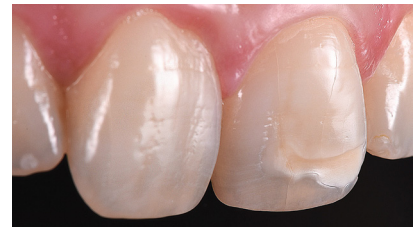
Fig. 3: Intra-oral oblique view on the traumatic hypomineralisation shows the absence of sound enamel on the surface.

After examination we concluded that the hypomineralisation was not covered with sound enamel and extended completely to the buccal surface of tooth 21. Moreover, the hypomineralisation showed both yellow and white discoloration. (Fig. 3, 4)

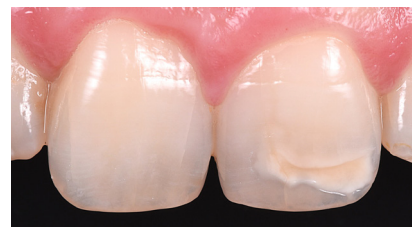
Fig. 4: Both white and yellow discolorations are present in the hypomineralised enamel lesion.

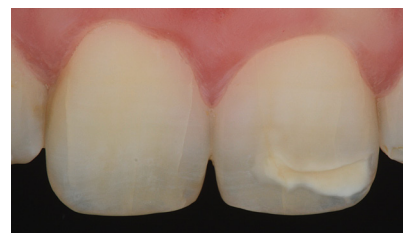
Fig. 5: Using cross-polarized photography there is no disturbance due to flash when analysing the colours of the tooth.

Taking cross-polarized pictures enables an even more meticulously analysis of the hypomineralisation. When taking cross-polarized pictures, both the flashlight (outgoing) and the lens (incoming) of the camera are polarized. This prevents the flash being visible on the pictures and enables better colour analysis. You can distinguish colours even better when you reduce the light by one level. In this case we could clearly see both the white and yellow parts of the hypomineralisation. But, even more importantly, we can also see that a part of the lesion was covered with sound enamel; mainly towards the mesial aspect. We should take this into account during our treatment procedures. (Fig. 5, 6)

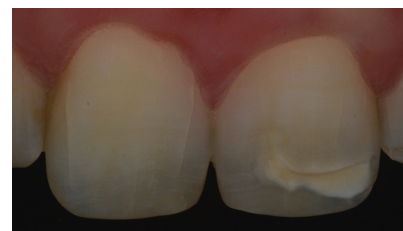
Fig. 6: When using one level lower of light, an even a better colour analysis can be achieved.

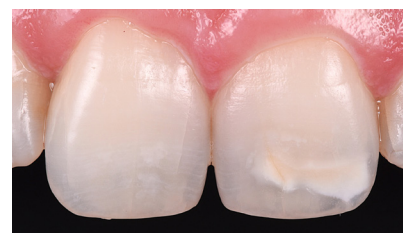
Fig. 7: Result after 10 days of home bleaching, seems pretty good?

Since there was quite heavy yellow discoloration present, home bleaching was advised with 16% carbamide peroxide during the night for 10 days. After 2 weeks we evaluated the result. At first, the result seemed very satisfactory on the photograph, but after analysis of the cross-polarized picture, the advice was to carry out a further 5 days of bleaching. (Fig. 7, 8) Due to the overall whitening effect, Katherina refused further bleaching and we continued the treatment after another 2 weeks rest due to bonding reliability after bleaching.

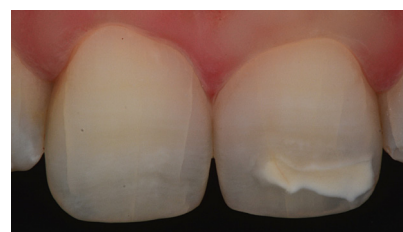
Fig. 8: Better analysis with cross-polarized photography shows us that the yellow discolouration is actually still present...

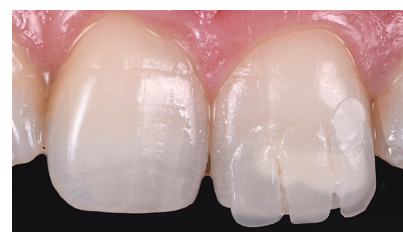
Fig. 9: In this case an enamel shade EB (enamel bleach), a Vita shade B1 and an enamel shade EL (enamel light) from Ecosite Elements (DMG) were applied from mesial to distal.

Before isolation the colours of tooth 21 were analysed with small amounts of the composite that will be used for restoration of the enamel disruption. With cross-polarized photography, selection of the correct composites is less of problem. After analysis, both the Vita shade B1 and the enamel shade EB (enamel bleach) from Ecosite Elements (DMG) were selected for restoration in this case. (Fig. 9, 10)

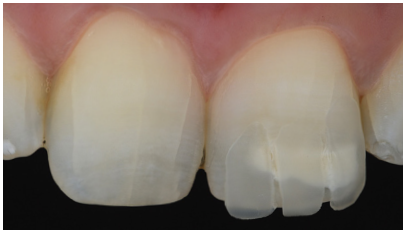
Fig. 10: Underexposed cross-polarized photography is very useful for easy analysis.

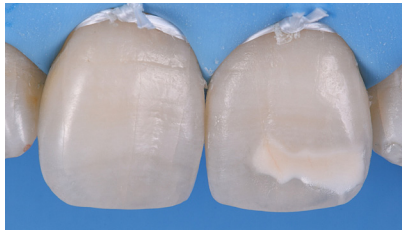
Fig. 11: Full rubber dam isolation using floss ligatures.

Once the correct composite shades were selected, full rubber dam isolation was carried out to prevent contact of both the etchant and the infiltrant with the soft tissue. Next, air-abrasion with aluminium oxide was performed to remove the surface layer of the hypomineralisation. The hypomineralisation extended to the surface and air-abrasion will be more aggressive on the hypomineralised part, due to the lower mineral content. (Fig. 11, 12)

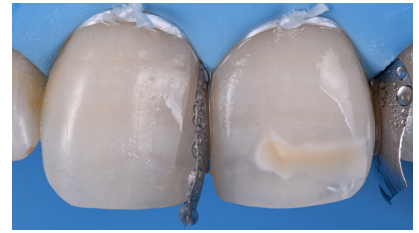
Fig. 12: Air-abrasion with aluminium oxide for superficial enamel removal.

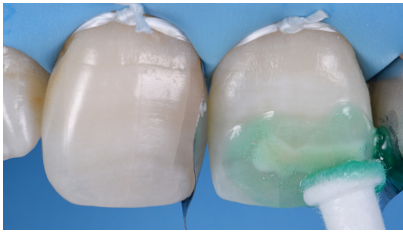
Fig. 13: Application of hydrochloric acid is carried out with active motion to enhance the etching effect.

For more careful enamel removal we started using hydrochloric acid. After each application, penetration was checked with ethanol. This procedure was repeated until the hypomineralisation showed full penetration capacity. (Fig. 13, 14)

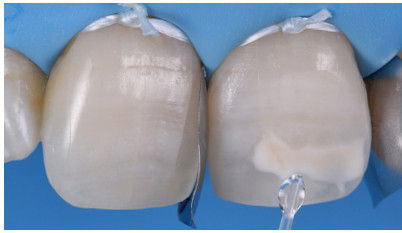
Fig. 14: Checking the penetration of ethanol into hypomineralisations is one of the key factors of success for the infiltration procedure in aesthetic cases.

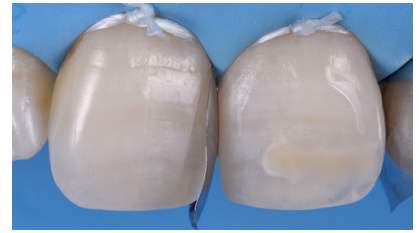
Fig. 15: Once the ethanol was applied after 3 etching cycles, it became clear that the mesial aspect of the lesion was still not completely accessible.

After 3 etching cycles the ethanol was unable to penetrate the hypomineralisation completely on the mesial aspect of the lesion. We had already analysed the cross-polarized pictures and ascertained that there might be some sound enamel covering the lesion, preventing good penetration. In this respect, some sound enamel was removed with a fine diamond burr. After 2 more cycles we were able to confirm good access. (Fig. 15, 16)

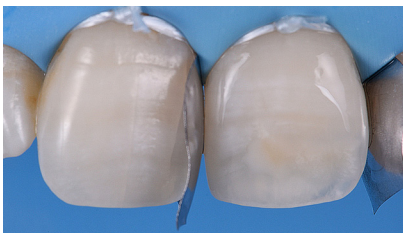
Fig. 16: Finally, after 5 cycles, we observe full penetration of the hypomineralisation.

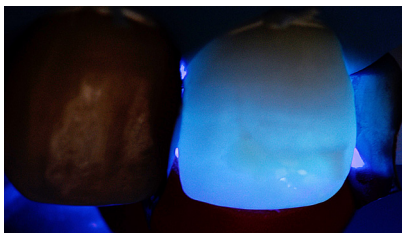
Fig. 17: Polarized transillumination picture to analyse the extent of the lesion in the enamel.

Before starting the infiltration procedure a transillumination photograph was taken from the lesion. For this technique we used a light source on the palatal aspect of tooth 21 and took a polarized picture from the buccal without using a flash. I used a light curing device with a special blacklight lens, to reduce the amount of light and to be able to take a photo. With this picture we can analyse the extent of the hypomineralised lesion; the darker the lesion, the greater the extent. So with Katherina we expected to have the greatest difficulties during infiltration on the distal aspect of 21. We started with the infiltration and used 5-minute intervals to activate and check the process of infiltration. (Fig. 17, 18)

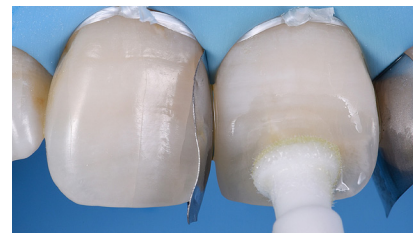
Fig. 18: Application of the infiltrant to start the infiltration procedure.

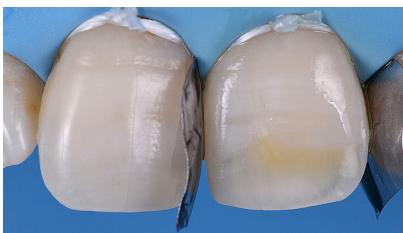
Fig. 19: Situation after 15 minutes of infiltration.

After 15 minutes of infiltration we had not been able to reach a desirable outcome; the distal aspect was not completely infiltrated. We decided to wait a little longer, and after 5 more minutes the distal area was successfully infiltrated as well. (Fig. 19, 20)

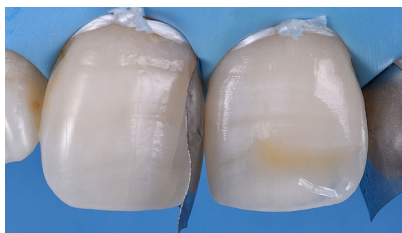
Fig. 20: After 20 minutes in total, complete infiltration of the lesion was achieved.

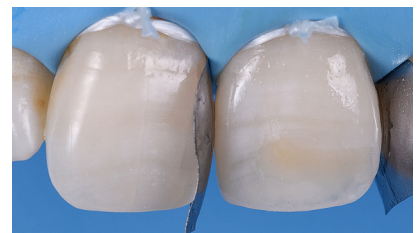
Fig. 21: The yellowish tint is gone after light curing, due to the fact that the photoinitiator is consumed.

Before light curing there was clearly a yellowish tint visible of the infiltrant. This is due to the photoinitiator inside the infiltrant. Once light cured the photoinitiator will be completely consumed and the yellow aspect will disappear. It is important to leave no excess of infiltrant before light curing; some air and suction will prove to be of great help.

Because we planned to carry out some adhesive bonding, only 1 infiltration cycle was performed. After infiltration, a normal adhesive protocol for enamel was carried out; sandblasting with aluminium oxide, etching with phosphoric acid and (total-etch) bonding. (Fig. 21, 22)

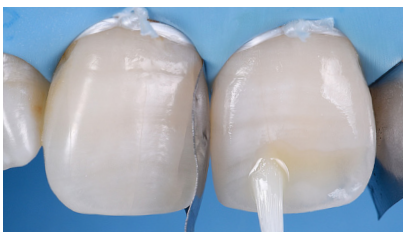
Fig. 22: Bonding agent is applied.

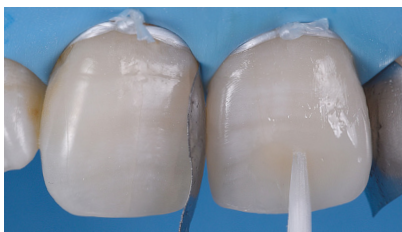
Fig. 23: Final enamel composite layer was finished with a fine brush.

Because there was still a little yellow discolouration present in the hypomineralisation, an initial layer of B1 Ecosite Elements was applied, as it has better abilities to block the colour underneath. After light curing, a very thin layer of EB Ecosite Elements was applied and polished after light curing with a diamond coated silicone spiral. (Fig. 23, 24)

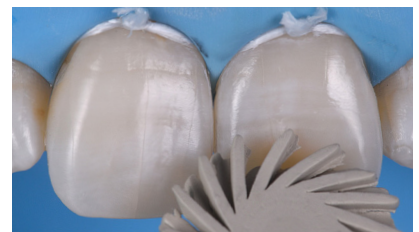
Fig. 24: Final polish with a diamond coated silicone spiral.

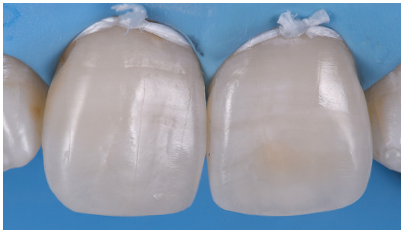
Fig. 25: Immediately after treatment under rubber dam.

The immediate result after treatment is difficult to analyse, due to the dehydration effects of rubber dam application. We could see a nice intact buccal surface, but still a little yellowish tint present... (Fig. 25, 26)

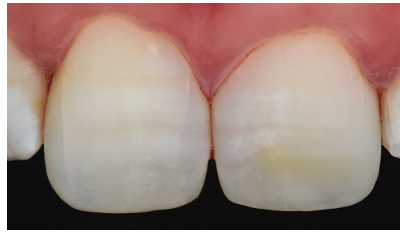
Fig. 26: Cross-polarized analysis which shows us still a little yellow discoloration on the 21.

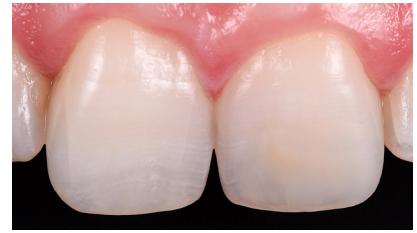
Fig. 27: Final result after infiltration, the defect is practically invisible.

After 2 more weeks the final evaluation was complete. Katherina was very happy with the result. The teeth rehydrated and the discolouration was almost gone. Only when analysing a cross-polarized underexposed picture could we still distinguish a very small amount of discolouration. (Fig. 27, 28, 29, 30)

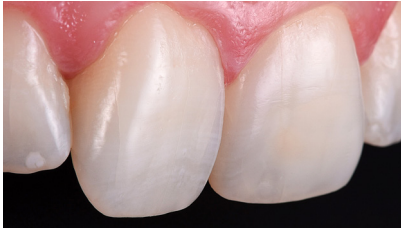
Fig. 28: Oblique view of the final result; the surface is completely restored.

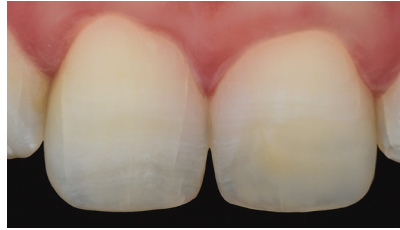
Fig. 29: Cross-polarized picture with normal exposure to analyse the final colours.

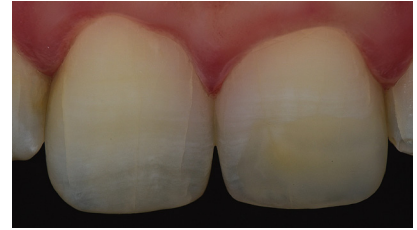
Fig. 30: An under exposed cross-polarized picture is the best way to evaluate the final result; we can still see a small amount of yellow discoloration present.

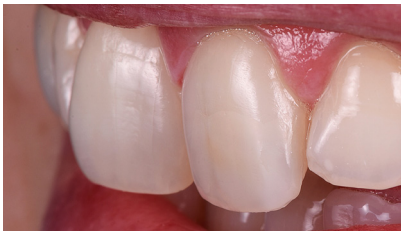
Fig. 31: Final result.

Final extra oral results are pleasing and show the possibilities when the infiltration concept (Icon) is combined with direct composite (Ecosite Elements). In the authors view it makes sense to combine both techniques and we would encourage other clinicians to do so when necessary. (Fig. 31, 32)
