# Ecosite Elements

## Case Reports

A series of case reports showing clinical solutions with Ecosite Elements.

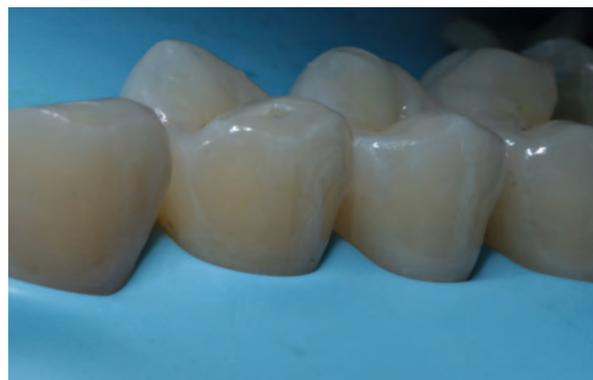
Fig. 2: Rubber dam isolation of the treatment area

The patient presented with a posterior composite with secondary caries, which needed replacement (Fig. 1). The quadrant was isolated with a rubber dam to ensure adequate moisture control and good visualisation (Fig. 2). This was a minimal restoration, with all caries removed and the melo-dentinal junction (ADJ) cleared (Fig. 3). This was a perfect case for applying the Ecosite Elements Pure and Highlight Shades. Here, A2 was used in the traditional incrementally layering fashion. Each increment was placed and thoroughly adapted; using a microbrush to minimise the void formation process between subsequent layers. The final layers were then constructed using the cusp-by-cusp method to recreate the natural anatomy.

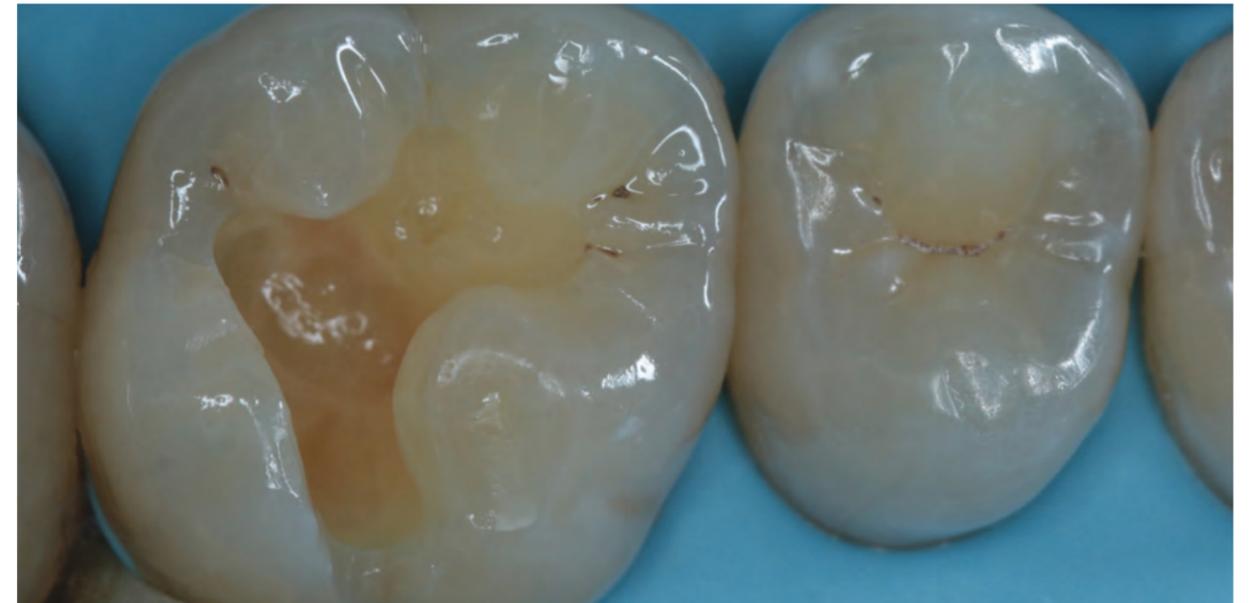
Fig. 3: After removal of the caries tissue

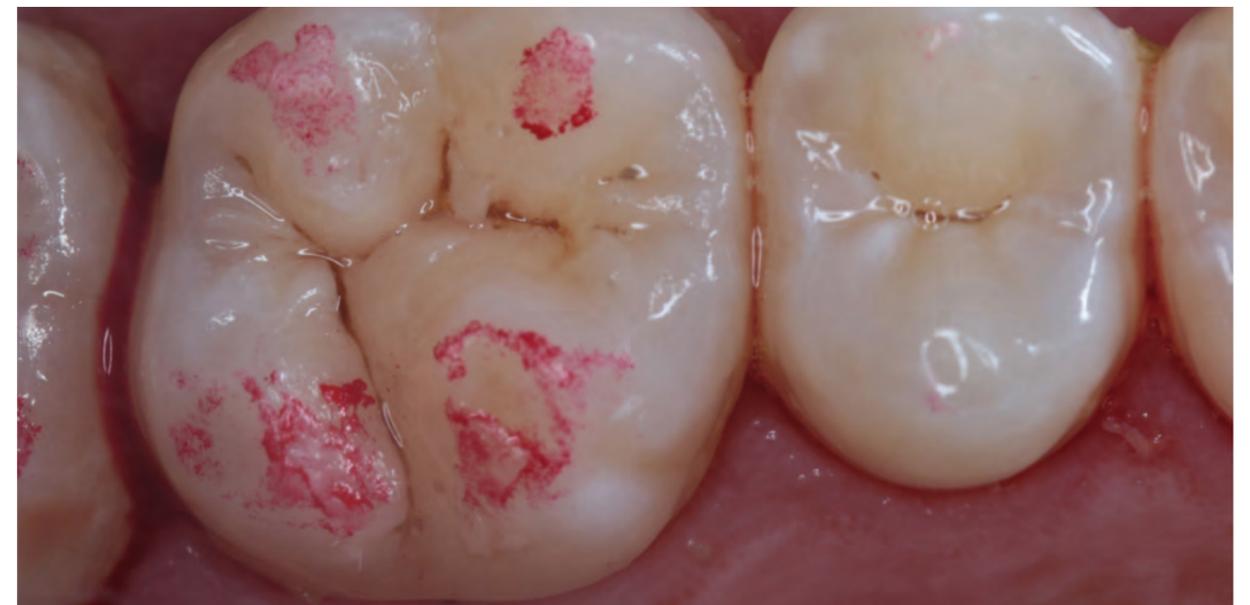
Fig. 4: Final situation after polishing and control of the occlusion

The fissure system was filled with the brown tint from the highlight set, which functions not only to seal any occlusal voids between the fissure anatomy created with the cuspal stratification technique, but also to create a natural-looking restoration which can be integrated from an esthetic perspective. The final cure is undertaken through glycerine gel to remove the oxygen-inhibition layer and maximise the hardness of the restoration as soon as the treatment is finished. The final aspect involves ensuring the restoration is integrated into the patient's habitual occlusal scheme. The restoration is then tested in static contact and excursive movements. As Figure 4 shows, this restoration did not cause any hindrance in terms of static or dynamic occlusal load. Ultimately form follows function, which, in turn, aids longevity.

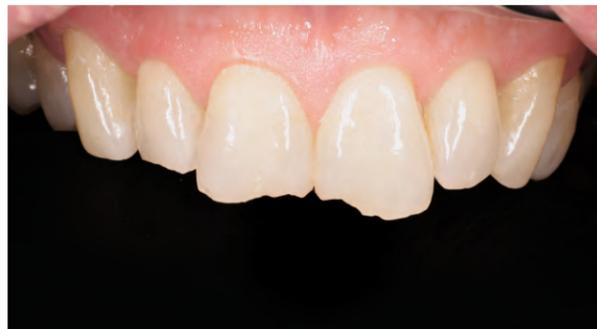
Fig. 1: Initial situation, with Ellis II fractures of the two central incisors

A 43-year old male patient spontaneously attended our practice with Ellis II fractures of the two central incisors after biting on a peach stone (Fig. 1). As the patient works as a consultant and had a job-related appointment the same day, he demanded swift and immediate esthetic rehabilitation.

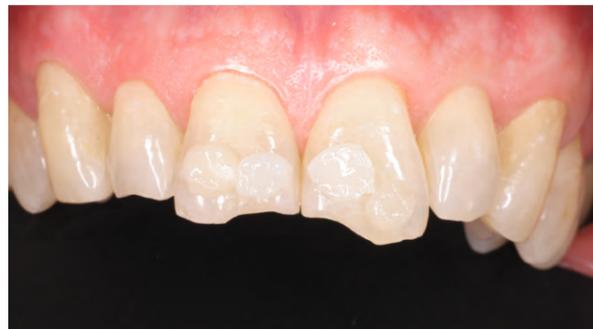
Fig. 2: Color preselection after preparing and cleaning the tooth surfaces

The sharp edges were removed, and a buccal bevel prepared. After cleaning the tooth surfaces, a color preselection was conducted and Ecosite Elements A3 with an EM Layer was chosen (Fig. 2). The tooth surfaces were etched for 30 seconds (starting with the enamel surface only, then, after 15 seconds, also covering dentin areas with etching gel for a further 15 seconds) with phosphoric acid (DMG etching gel 37%) (Fig. 3). Subsequently, a matrix band was applied between the two central incisors before the bonding step was carried out using DMG Ecosite Bond (Fig. 4).

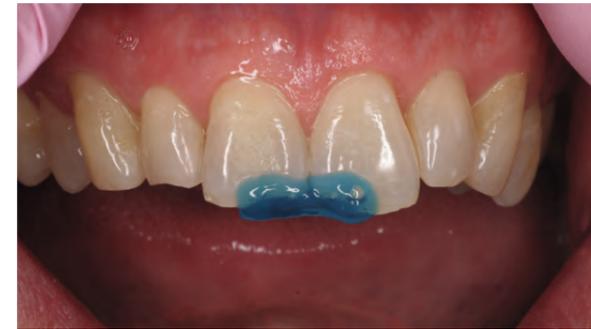
Fig. 3: Total-etch technique to prepare the surfaces

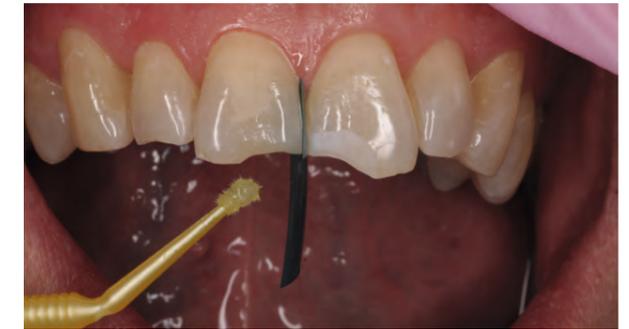
Fig. 4: Tooth 11 – Application of Ecosite Bond

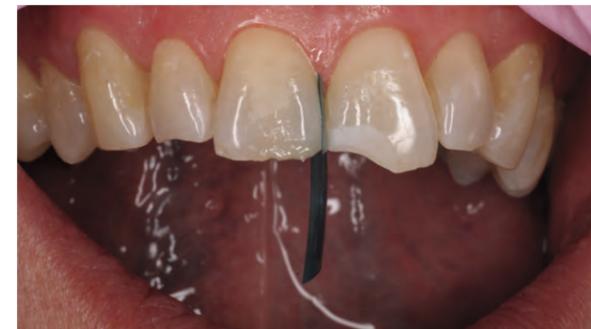
Fig. 5: Tooth 11 – Application of the first increment Ecosite Elements A3

The first increment used was an A3 applied freehand and irregularly to achieve a natural look (Fig. 5). Next came the final EM Layer of the Ecosite Elements Layer set (Fig. 6). Each increment was light-cured for 20 seconds. A first rough contouring and finishing step with Soflex discs and a diamond bur were performed, before the separation and bonding procedure was performed on tooth 21 (Fig. 7).

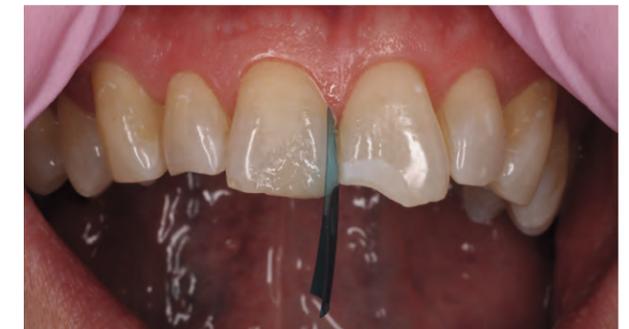
Fig. 6: Tooth 11 – After the application of the enamel layer (Ecosite Elements EM)

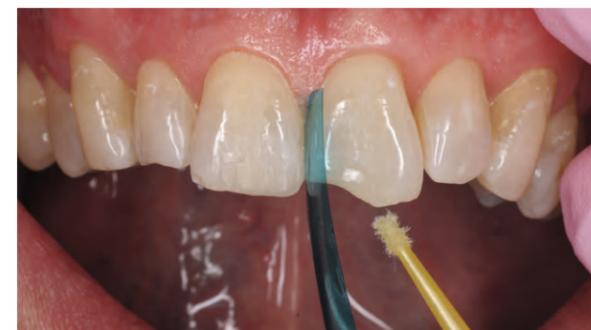
Fig. 7: Tooth 11 – after contouring; Tooth 21 – Application of Ecosite Bond

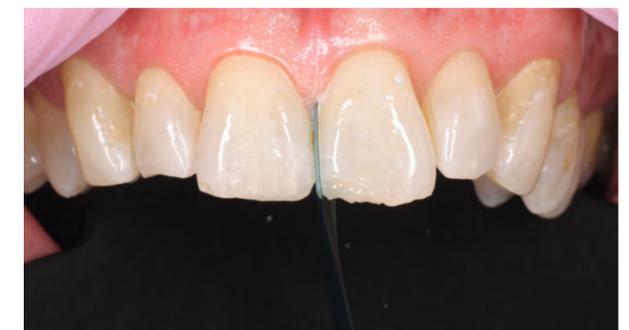
Fig. 8: Tooth 21 – Application of the first increment Ecosite Elements A3

As previously, tooth 21 was built up using a multilayer freehand technique (Figs. 8, 9). Subsequently the restorations were contoured, finished and finally polished with composite rubber polishers and a silicon carbide brush. Figure 10 shows the final situation.

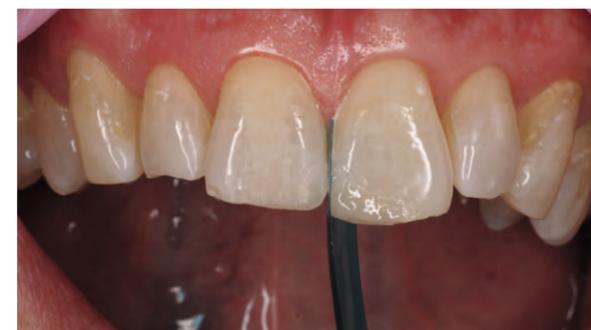
Fig. 9: Tooth 21 – Following the application of the enamel layer (Ecosite Elements EM)

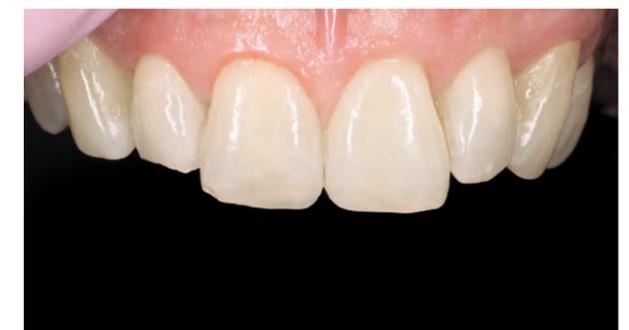
Fig. 10: Final Situation after polishing

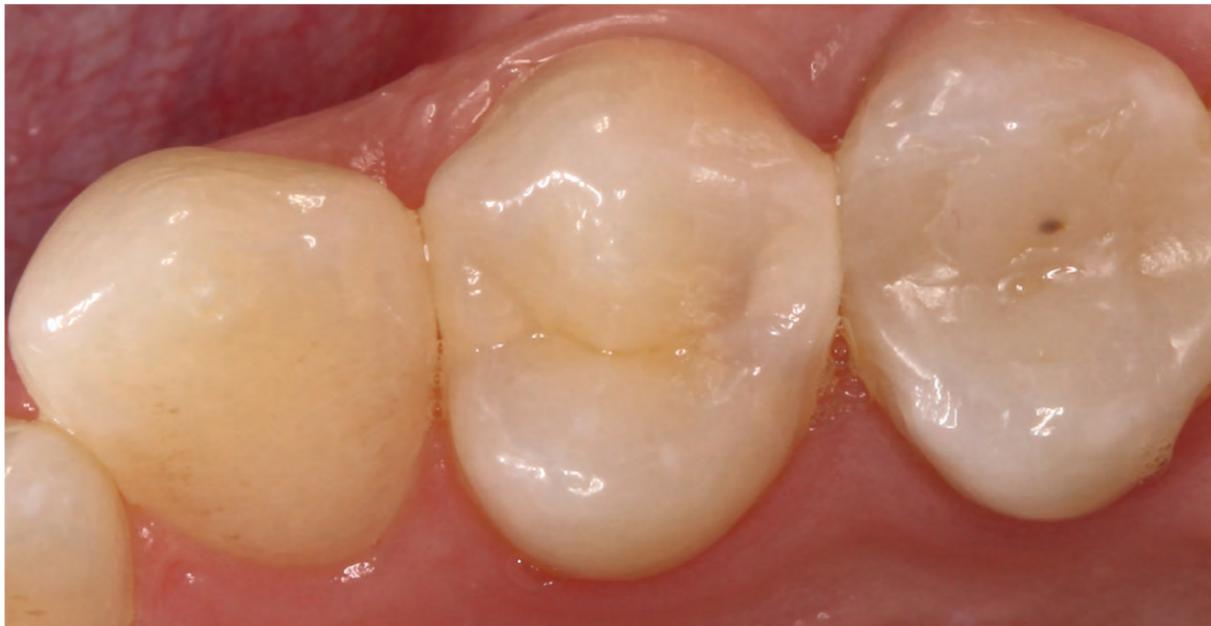
Fig. 1: Initial situation

During clinical examination, a distinct shadow was visible in the distal area (Fig. 1).

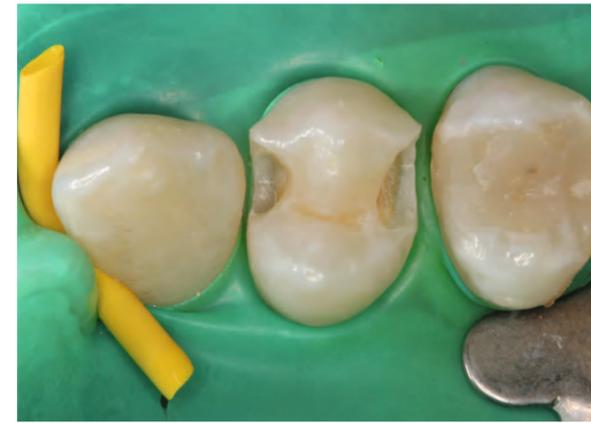
Fig. 2: Situation after isolating the working area and removing the carious tissue

After isolation of the working area, the carious lesions were exposed, followed by removal of the carious tissue (Fig. 2).

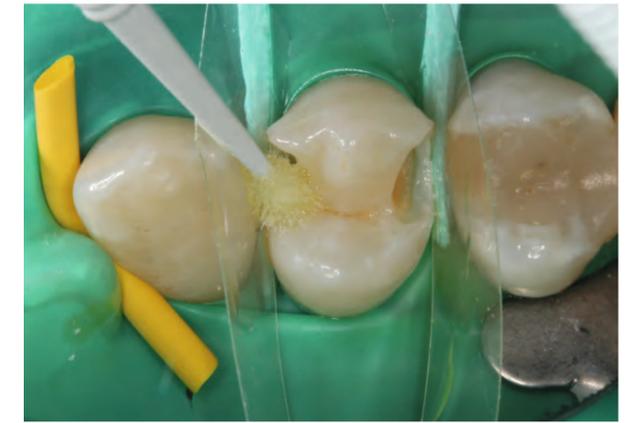
Fig. 3: Application of the Ecosite Bond

Ecosite Elements (shade B1) was used in combination with the Ecosite Bond which can be applied both as a swift and reliable self-etching bonding as well as a selective- or total-etch system (Fig. 3).

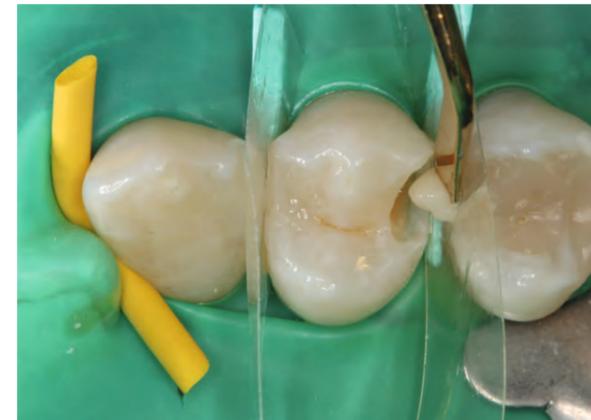
Fig. 4: Application of Ecosite Elements B1

The color matching of the composite is easy, since the material integrates very well into the restored tooth (Fig. 4).

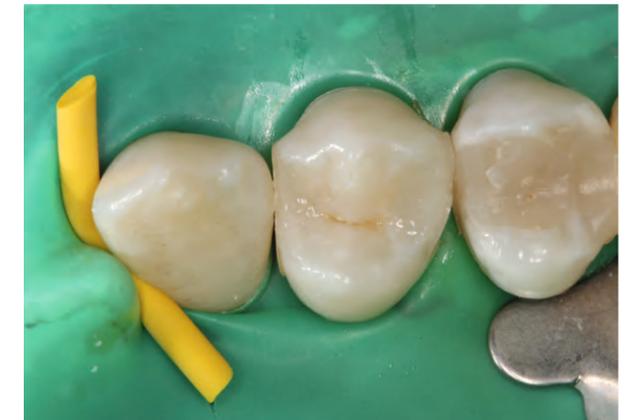
Fig. 5: Final modulation after removing the matrix

These properties do not only improve the handling and adaptability before light curing but also make polishing easier after having placed the filling (Fig. 5); an approach allowing esthetically favourable results with minimal effort (Fig. 6).

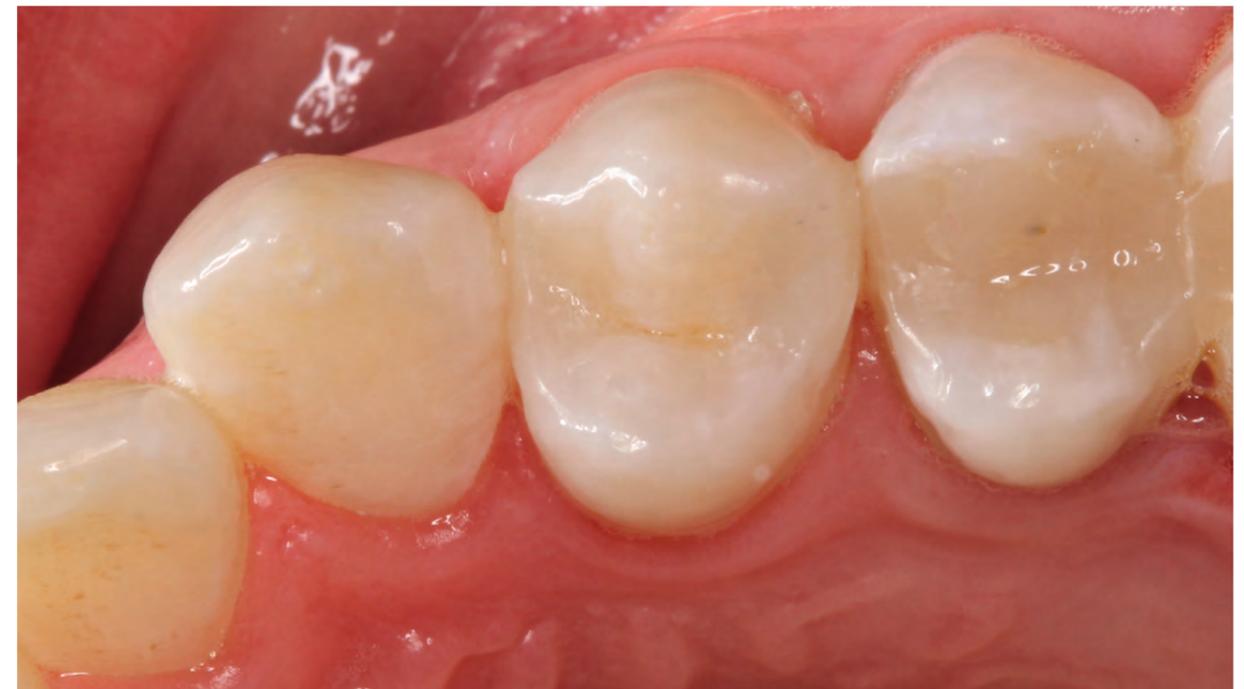
Fig. 6: Final situation after polishing

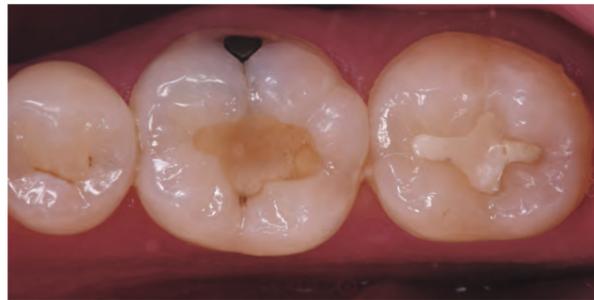
Fig. 1: Initial situation, small leakage of the old composite 36 is visible. The x-ray showed secondary caries under the amalgam of tooth 36 and underneath the composite 37

A 35-year-old female patient presented herself in my practice as a new patient. Teeth 37 and 36 were diagnosed with secondary caries under composite and amalgam fillings (Fig. 1). Precise removal, cleaning and replacement with a new composite was advised.

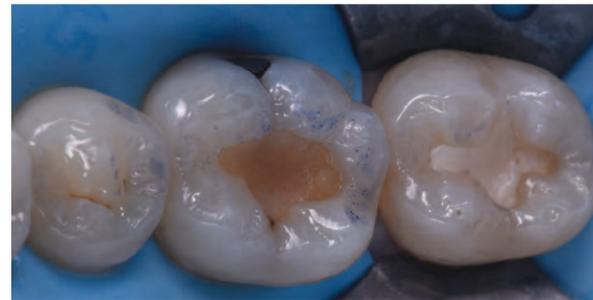
Fig. 2: After isolation with rubberdam to ensure a clean and proper operative field

Following local anaesthesia, the treatment site was isolated with rubberdam (Isodam Heavy, SDS) using a special marked stamp (DDC Stamp, K-Dental), a basic clamp (12A, Hygienic) and a floss ligature (PFTE Floss, Tandex). Before isolating, occlusion and articulation was checked for with an articulating paper (Arti-Fol, Bausch) (Fig. 2). Once isolated the old composite and amalgam were removed. The amalgam was removed with a special tungsten carbide bur (H32, Komet) and the composites with a small regular diamond (Fig. 3).

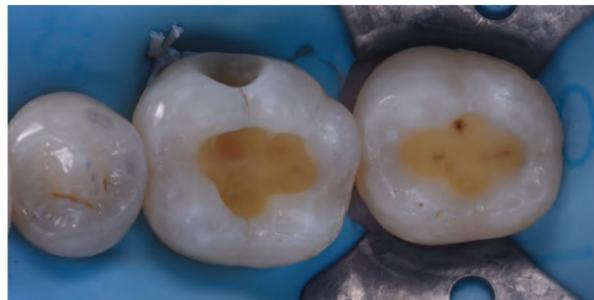
Fig. 3: The old amalgam and composites are removed. Secondary decay is removed with a round excavator tungsten carbide bur

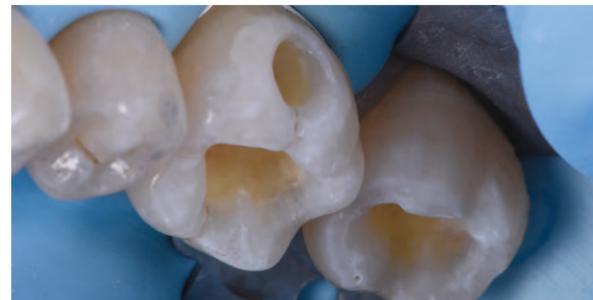
Fig. 4: After selective etching of 30 seconds, the enamel shows crispy white

Final removal and excavation was done using a round excavator tungsten carbide. Enamel edges were bevelled with a special stone (Dura Greenstone, Shofu), whereupon the preparation was sandblasted with 29µm aluminumoxide (Aquacare Twin, Velopex). Next, selective enamel etch with 35% phosphoric acid was performed (UltraEtch, UltraDent) for 30 seconds (Fig. 4). After rinsing thoroughly with water, universal bonding was applied (Ecosite Bond, DMG) and rubbed for 30 seconds (Fig. 5), gently dried with air for 5 seconds and light-cured for 10 seconds using an LED polymerization device (VALO, Ultradent). The composite build-up starts with an initial dentine layer using shade A3.5 (Ecosite Elements A3.5, DMG). This layer is applied flat and equally divided, with the surface located 2.5mm below the cusps. Final adjustments of the dentine layer can be done with a brush (Mirobrush, Microbrush International). Light curing is then done

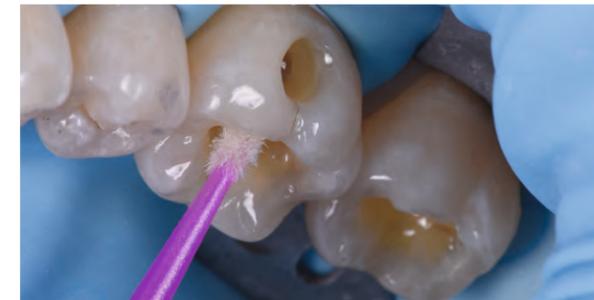
Fig. 5: Ecosite Bond is applied and rubbed for 30 seconds

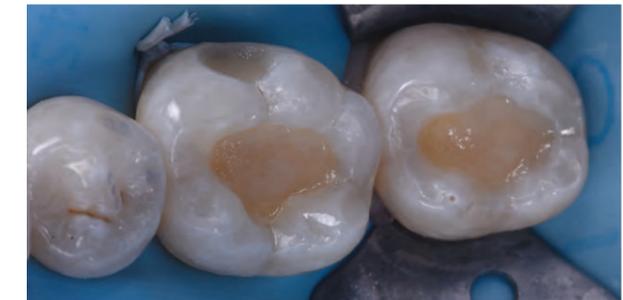
Fig. 6: A small amount of dentine composite (Ecosite Elements A3.5, DMG) is applied as the first layer

for 20 seconds (Fig. 6). Next an enamel shade is used to reshape the anatomy shape of the tooth (Ecosite Elements EM, DMG). Each cusp is reconstructed step-by-step. (Fig. 7) Special instruments used are a very thin explorer (Fissura, LM Arte) and a brush (Round Brush #1, GC). Inclination of the cusps is monitored from the side. The layered concept with a 'dentine'-like base-layer creates a 3D-effect since the translucency of an enamel composite is higher at the fissure than at the top of a cusp (Fig. 8). And after excess removal staining is done with special stain flowable composite (Ecosite Elements Brown, DMG) (Fig. 9). Being subtle with the staining is the key, but sometimes very difficult. After staining excess composite can be removed using a tungsten carbide and a special stone (Dura Greenstone, Shofu). Final polishing is done with wheels (Diacomp Twist, EVE), rubberdam is removed and occlusion and articulation were checked. Some final

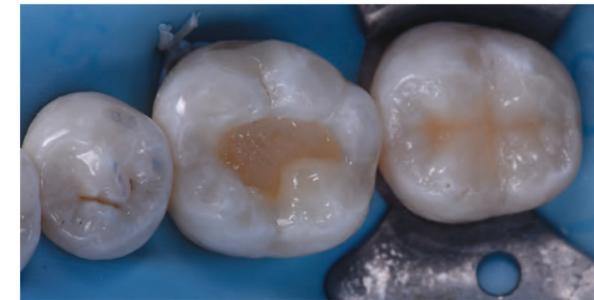
Fig. 7: One by one, each cusp is sculpted with an enamel composite (Ecosite Elements EM, DMG)

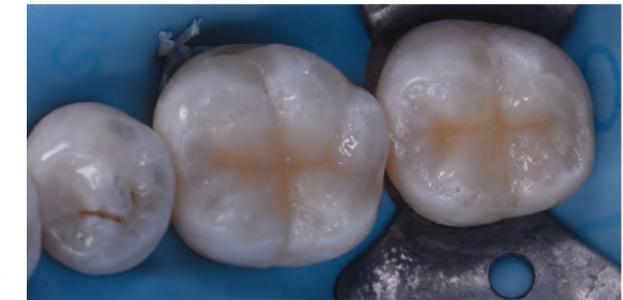
Fig. 8: After modelling the dentine and enamel composite

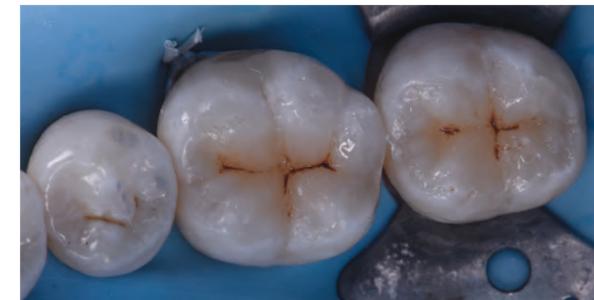
Fig. 9: Immediately after applying the brown staining

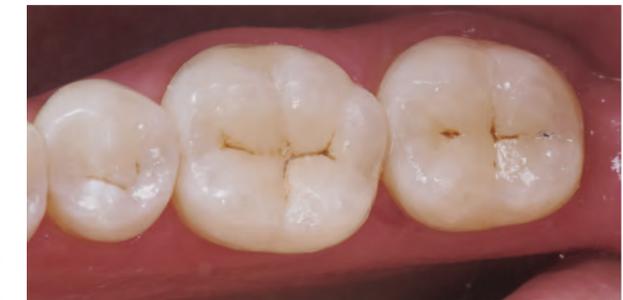
Fig. 10: Final result after polishing and 4 weeks of function

adjustments were necessary with a fine diamond. Those adjusted areas were polished again and a final polish was performed with aluminium oxide paste (Enamelize, Cosmedent) and a goat hairbrush (Goat Hair, Polirapid). Final result after 4 weeks in function (Fig. 10).

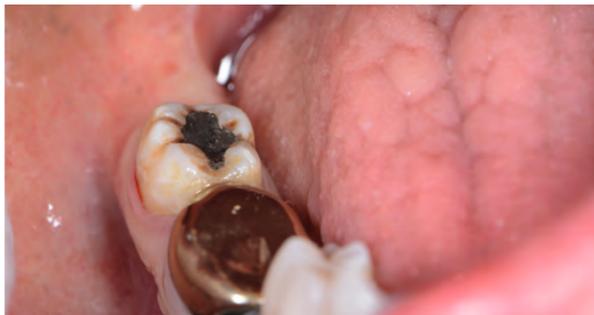
Fig. 1: Initial situation with amalgam filling

A young patient (34) arrived at our dental office to have her tooth's old amalgam filling replaced with an esthetically more acceptable material (Fig. 1). We opted for a DMG Ecosite Elements composite available in pure colors (e.g. B1, A2, A3, A3.5, A4) and combinable with layering shades for enamel (Enamel Bleach, Enamel Light, Enamel Medium, Enamel Dark – later in text EB, EL, EM, ED). Under more demanding circumstances, highlight elements can also be used, of which we will now cite only Opaque A2 as a flowable composite. Having removed the amalgam filling and cleaned the cavity, we noticed dark dentin discolorations, constituting tertiary dentin and an amalgam tattoo and often found in teeth having an amalgam filling without any lining. The dark dentin discolorations were only removed for esthetic reasons, as they showed no signs of caries (Fig. 2). To evaluate caries, we used the Caries Indicator by Henry Schein. To be as minimally invasive as possible, the decision was made to leave the discolorations and hide them with a lining of composite Opaque A2 DMG Ecosite Elements.

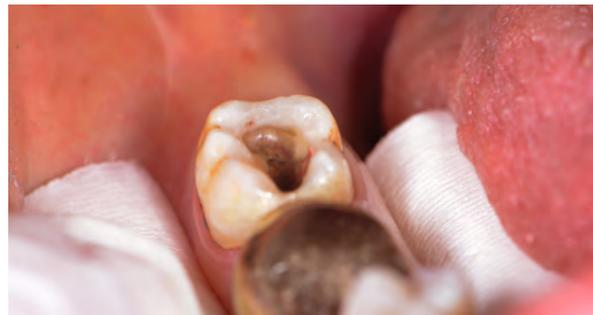
Fig. 2: Discoloration after removing the amalgam filling

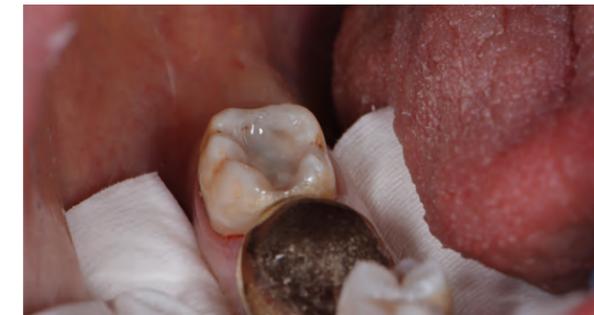
Fig. 3: Cavity appearance after using and light-curing the flowable OA2 Ecosite Elements

Flowable composites show great self-adapting properties in cavities as well as great fluidity. Thanks to these properties, the material has wide-ranging applications in our everyday work. After placing only 1 mm of flowable OA2 and light-curing it for 20 seconds, we can see most of the discolorations are already covered (Fig. 3).

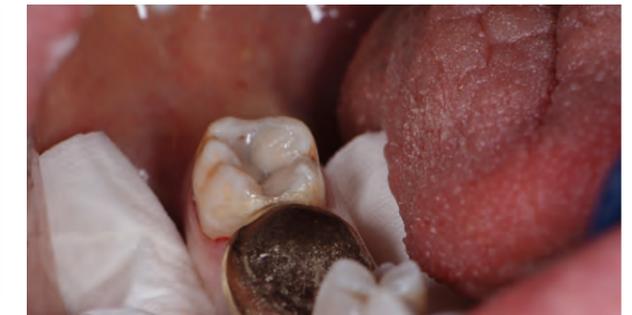
Fig. 4: Cusps modelling with A2 Ecosite Elements

For the dentin layer, we use A2 Ecosite Elements. It can be used as a single layer or combined with enamel colors, as was done in this case. First, the cusps were layered with A2 to achieve the basic restoration morphology, while leaving space for the enamel layer (Fig. 4). Each layer was then light-cured for 20 seconds and the composite applied to buccal cusps, taking into account that space was still needed for the enamel layer. After the dentin layer, a thin enamel layer – EL (Enamel Light) in this case – was applied to each cusp separately and light-cured (Fig. 5).

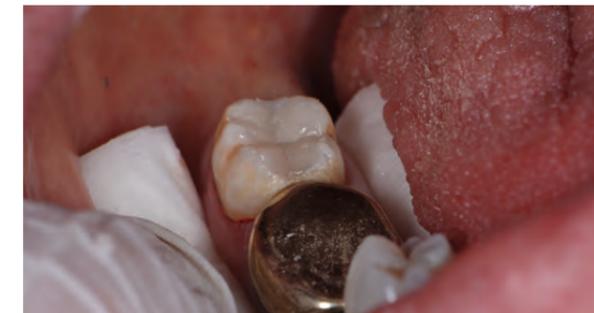
Fig. 5: After the dentin layer, applying a thin layer of EL (Enamel Light) Ecosite Elements

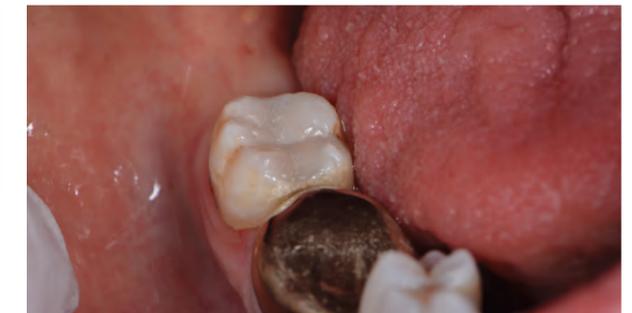
Fig. 6: Final restoration appearance prior to occlusal check and final polishing

The occlusion was checked and materials prepared for final polishing (Fig. 6). Note the fine occlusal surface morphology, which can be easily reproduced using the correct materials. DMG Ecosite Elements has excelled in this field as it does not stick to the instruments and is extremely easy to shape.

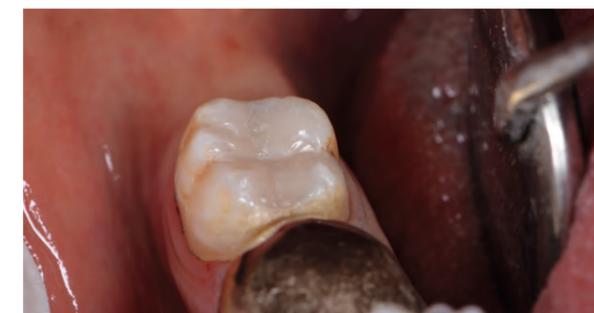
Fig. 7: Enlarged picture of final restoration. Perfect tooth-restoration transition, highly polished surface

An enlarged picture (Fig. 7) of our final restoration shows the amazingly polished surface of Ecosite Elements composite, rendering

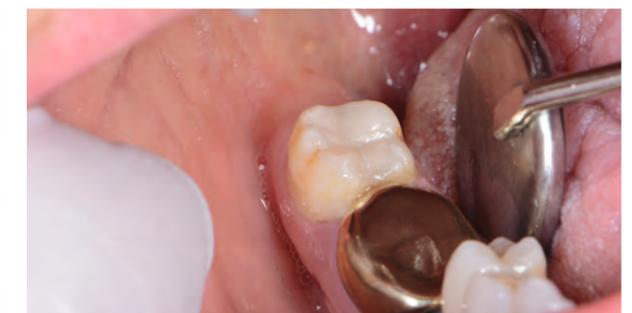
Fig. 8: Result one day after the treatment with perfect shade matching because of the rehydration of the tooth

it multifunctional and one of the most practical restoration solutions in all areas, especially direct restorations in anterior teeth (Fig. 8).

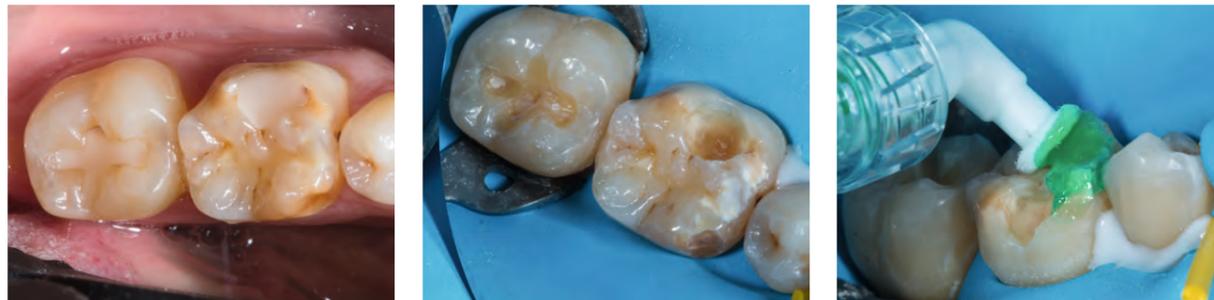
Fig. 1

Fig. 1: Initial situation tooth number 46 – old composite filling on the mesio-buccal cusp, also including brown and white spots (MIH syndrome), Part of the mesio-lingual cusp is also broken; Tooth 47 – an old occlusal composite filling. Fig. 2: The old fillings were removed and the cavities properly cleaned up. Fig. 3: The white areas are first sandblasted, then Icon-Etch is applied for 2 min to the same.

Initial situation with tooth number 46 presenting an old composite filling on the mesio-buccal cusp as well as brown and white spots specific to all patients with MIH syndrome. Part of the mesio-lingual cusp is also broken. Although tooth 47 has a normal aspect, it also has an old occlusal composite filling that needs replacing (Fig. 1). After rubber dam placement, the old fillings were removed and the cavities were properly cleaned up. The dehydration process following the isolation step makes the white spots even more opaque and visible on tooth 46 (Fig. 2).

Hypomineralisation spots of the tooth are really deep in MIH cases (close to the enamel-dentin junction), so the enamel covering the white areas is first sandblasted and then Icon-Etch applied for 2 min on the same spots. Combining the mechanical action of the sandblasting and the chemical erosion of the acid allows the top of the lesion to be reached faster to facilitate and streamline infiltration (Fig. 3).

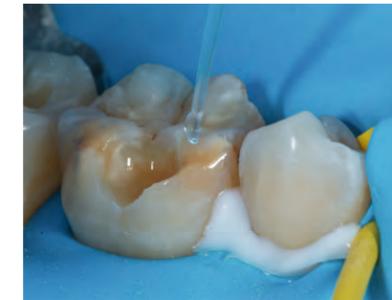
Fig. 4

Fig. 4: Icon-Dry was applied to simulate the pre-infiltration result and determine whether or not the lesion had been properly reached. Fig. 5: Icon-Infiltrant was applied for 3 min and then light-cured. Fig. 6: Result of the Icon treatment – the white spots have been masked. Fig. 7: Etching with 37% orthophosphoric acid. Fig. 8: Applying adhesive to the etched dentin and enamel. Fig. 9: Situation after building up composite on tooth 46 with Ecosite Elements Pure shade A3. Fig. 10: Situation after building up composite on tooth 47 with Ecosite Elements Pure shade A3 and polishing with a «two-step» technique using silicone rubber polishers. Fig. 11: Situation immediately after removing rubber dam. Fig. 12: Situation after one week recall, after rehydrating the teeth.

A microbrush was used to rub the Icon-Etch on the white spots to optimize its erosive action. Icon-Dry was applied to simulate the pre-infiltration result and verify whether or not the lesion has been properly reached. The first test with Icon-Dry shows that the lesion has not yet been properly reached (Fig. 4).
