A winning  
**smile?**

**Yes  
Please!**

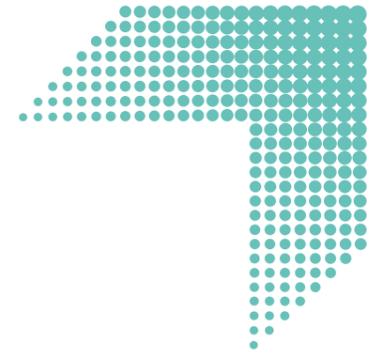
## Cariogenic white spot lesions.

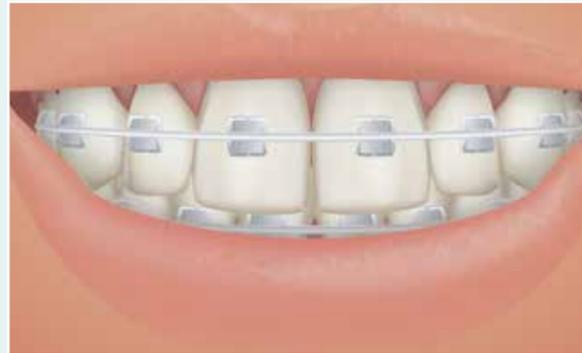
**Patient history or etiology.** Orthodontic treatment with fixed brackets.

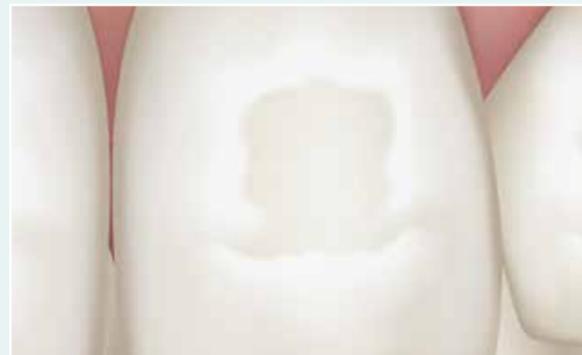
**Border.** Well-demarcated.

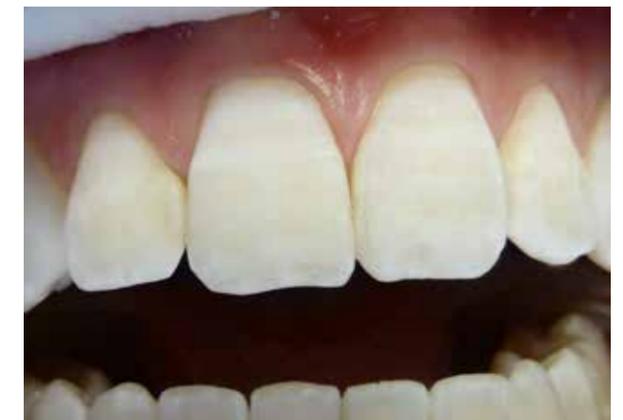
Fig. 7: Result after etching with Icon-Etch five times.

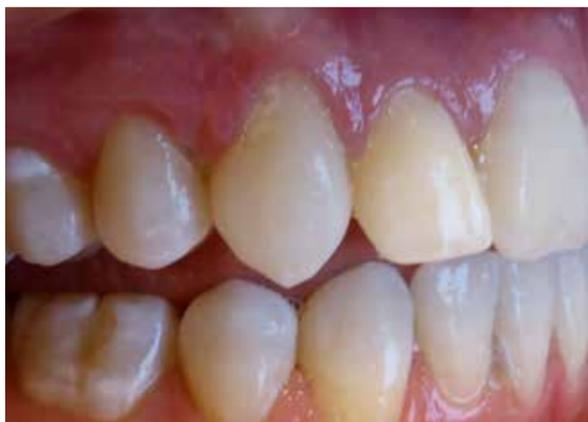
After infiltration, a significant masking was apparent, deemed highly satisfactory by the patient, of both the fluorotic enamel areas and the enamel areas decalcified by the orthodontic treatment.

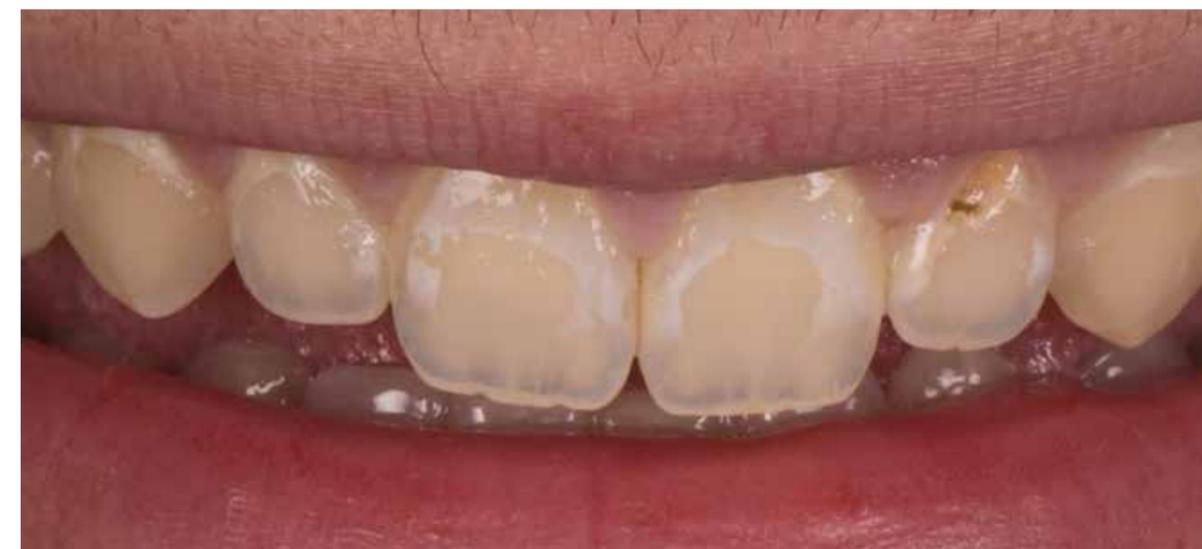
Fig.1: Initial situation before treatment with Icon.

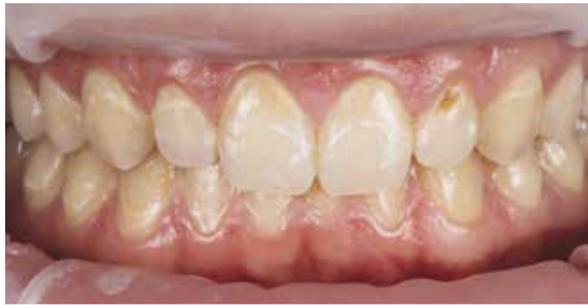
In order to fulfill the patient's desire of an esthetic improvement we suggested an Icon treatment to mask the lesions.

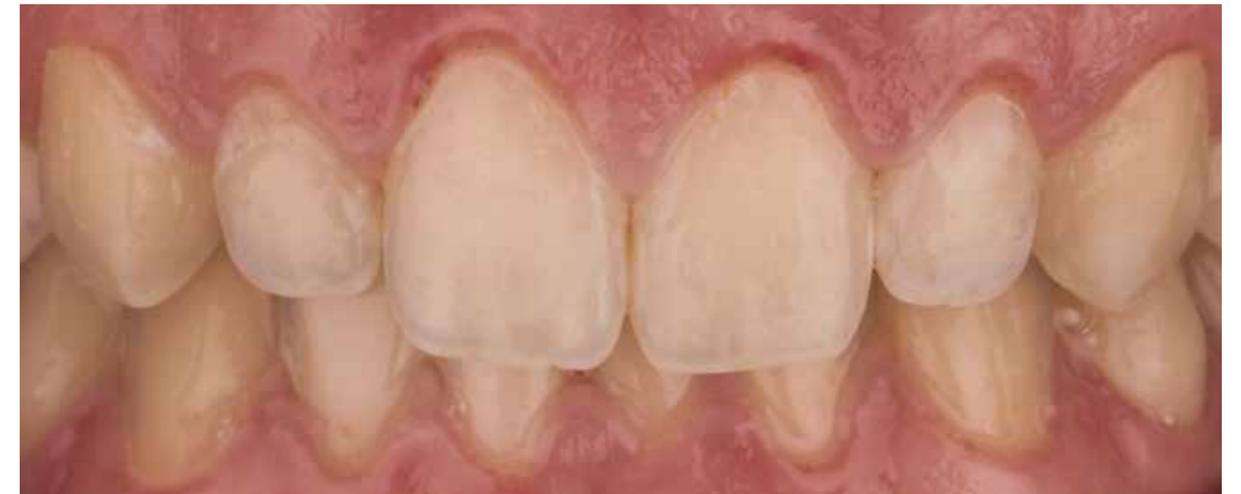
Fig. 10: Final result after Icon treatment.

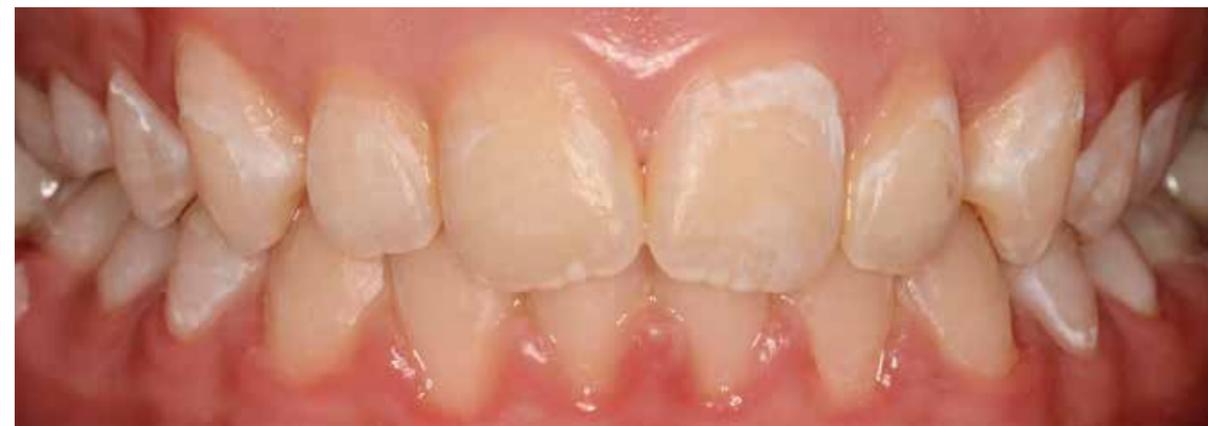
Fig. 3: Directly after removal of the brackets.

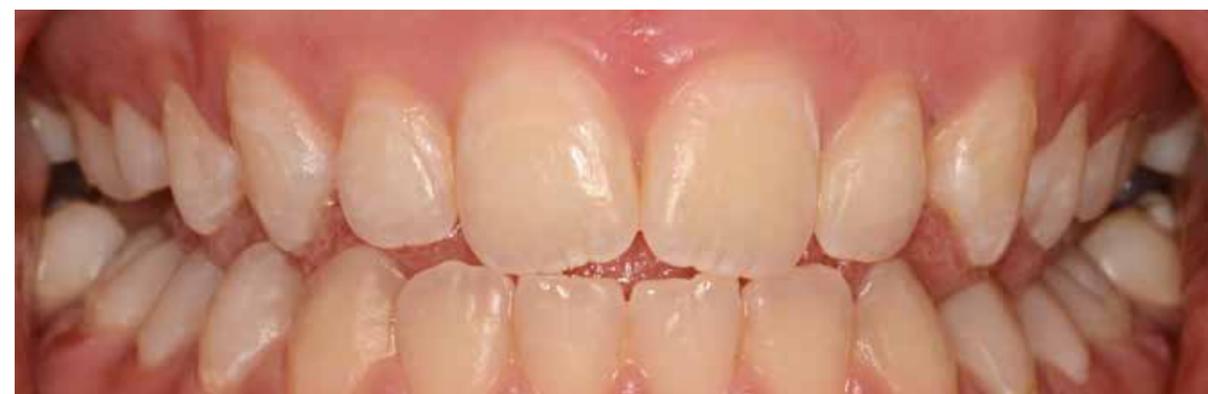
Fig. 4: One week after removal of the brackets and after infiltration of the control teeth.

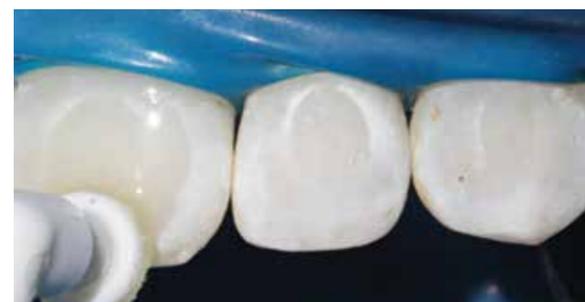
Post orthodontic white spot lesions treated with resin infiltration (Icon DMG). **Fig. 1:** Pre-operative photograph. **Fig. 2:** Dry field is essential for success. Rubber dam is placed to isolate the field and should be inverted, or ideally ligated, to prevent leakage or saliva contamination. **Fig. 3:** Prophylaxis with non-fluoridated pumice is completed; teeth are rinsed, then dried. Icon-Etch (hydrochloric acid) is applied, extrude the Icon-Etch by twisting the syringe. Etch should extend approximately 2 mm around the edges of the lesion and be placed.

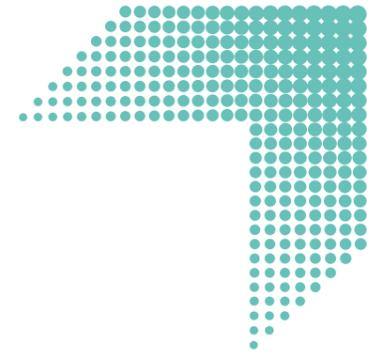
13. Phark JH, Choo KM, Duarte S, Sadan A. Influences on Bond Strength of Orthodontic Brackets. J Dent Res 89 (Spec Iss A): 1320 (2010).

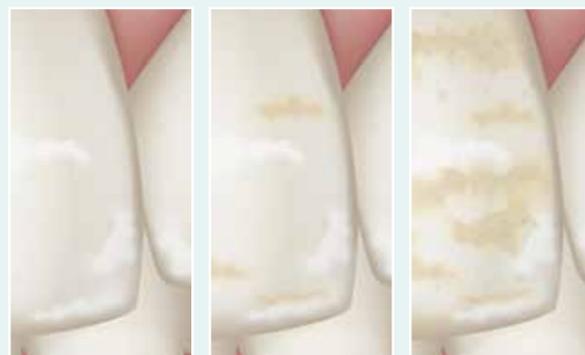
**Color.** From tiny white specks or streaks to dark brown stains and rough, pitted enamel, depending on the severity.

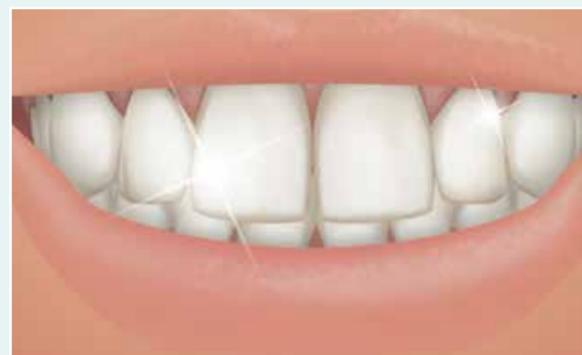
**Other unaffected teeth.** Smooth and glossy. They should also be a pale creamy white.

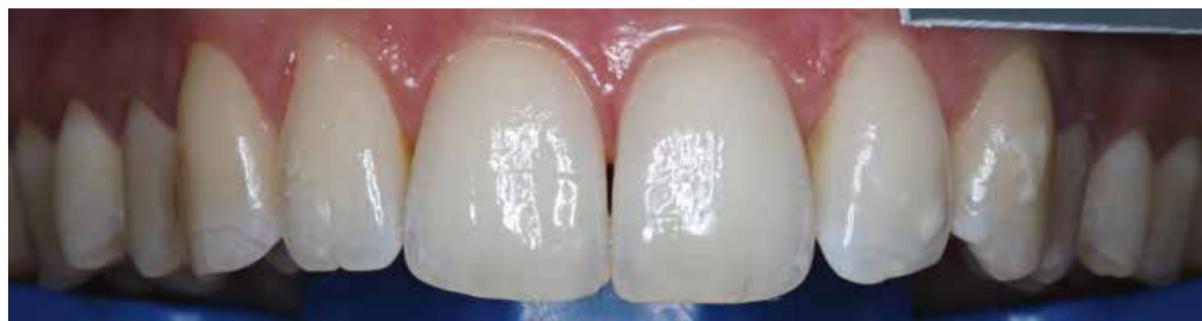
Fig. 1: Base status. Case 1.

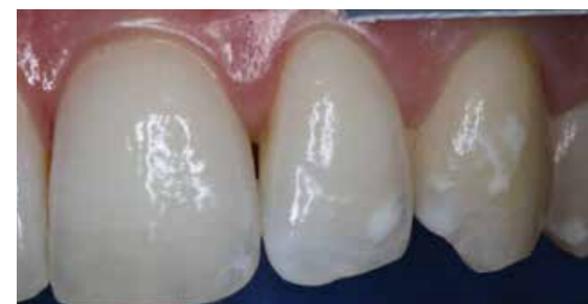
Based on positive results mostly published in case reports we hypothesised that in-office bleaching prior to resin infiltration improves the quantifiable and self-assessed aesthetic effect in mild to moderate dental fluorosis. 26 patients were included in a RCT. The test group received an in-office light enhanced power bleaching with 25 % hydrogen peroxide (Zoom, Philips, NL); the control group was pre-treated accordingly using an ACP gel (Relief Oral Care Gel, Philips, NL) instead of the active substance. After two weeks both groups were infiltrated (Icon, DMG, Germany). Digital images were taken at every appointment and after 1, 3 and 6 months respectively. Based on calibrated images Delta E-values between health enamel surface and fluorosis Spots were calculated. Additionally patients' were asked as to how they judge their overall appearance on a VAS (1-10).

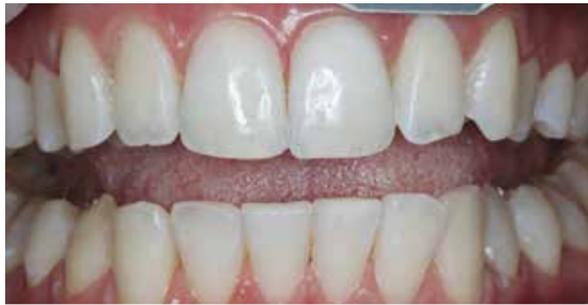
**Fig. 8: Case 1 before infiltration.** After in-office bleaching we waited for 2 weeks before the infiltration procedure. After rehydration the teeth appear more uniform yet brighter in colour. The treatment protocol intended application of hydrochloric acid for 6 minutes (three rounds, 2 minutes each) and 10 minutes of infiltration and one additional minute after the initial infiltrating procedure. The prolonged etching and infiltration increases the probability to sufficiently remove the intact surface layer and allows the infiltrant to homogeneously fill up deeper porosities. Apart from these modifications the infiltration process was performed as recommended by the manufacturer.

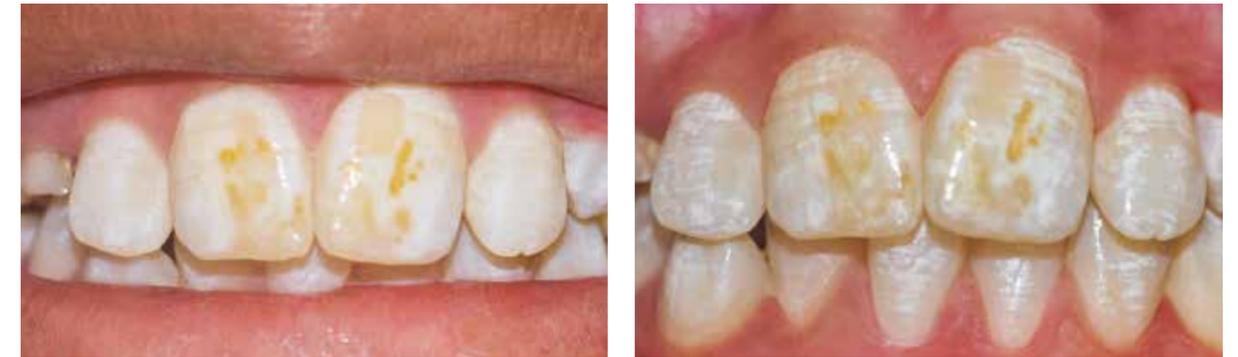
**Fig. 1-2:** Through a clinical exam, it was diagnosed that all of permanent anterior teeth, which were erupted, had fluorosis. However, the teeth 11 and 21 were more severely affected according to Thylstrup and Fejerskov index [12].

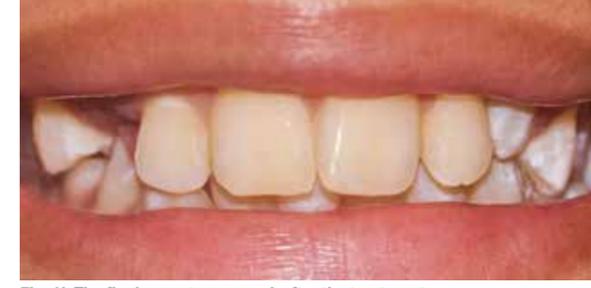
Fig. 11: The final aspects one week after the treatment.

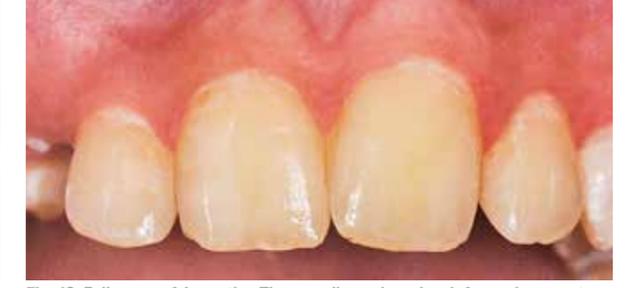
Fig. 12: Follow-up of 4 months. The guardians signed an informed consent form regarding all the procedures.

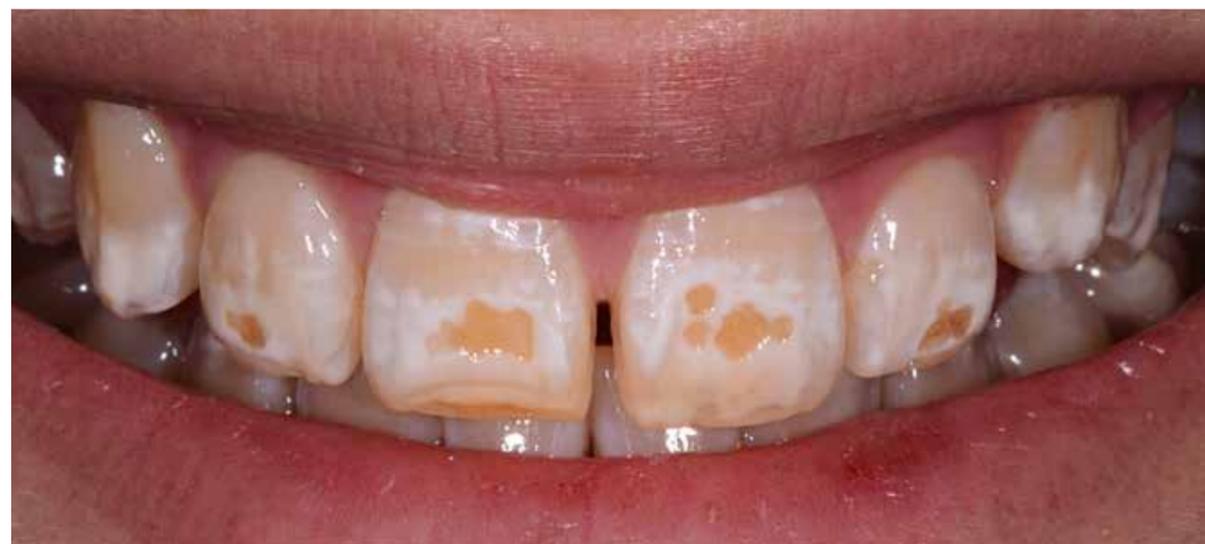
Prof. Dr. Leandro Augusto Hilgert, Marília Bizinoto Silva Duarte

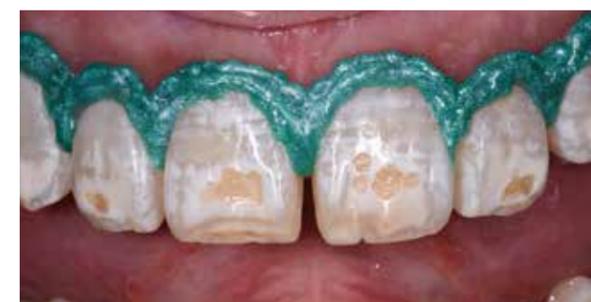
Fig. 1-4: Figures 1, 2 and 3 present different views of the clinical case in which the patient presents fluorosis (TF6). Observe that there are areas with diffuse and slight white opacities, areas with very opaque white opacities and areas that already present enamel loss and some discoloration. In Figure 4 transillumination was performed to check light transmittance through the enamel, that may be a useful diagnostic tool since the deeper the enamel hypomineralization, the more light is blocked. Some areas of the affected anterior teeth area were suggested to present deeper lesions, that may impair a more complete resin infiltration without some previous wear of the enamel.

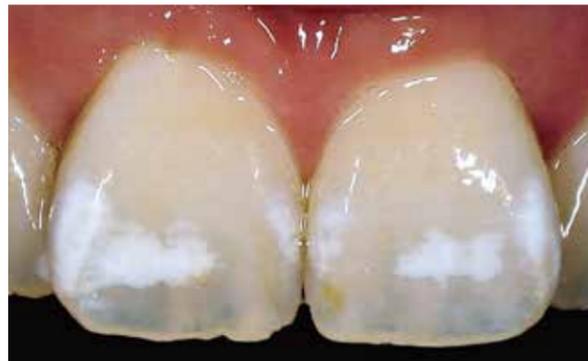
Fig. 1: Frontal view of the white spots 11, 21.

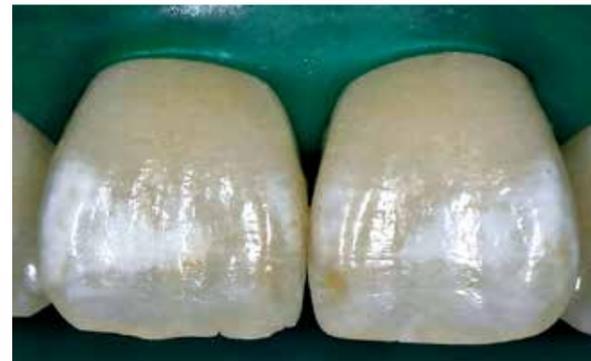
Fig. 2: Firstly, the teeth should be cleaned or (as in our case) a professional dental cleaning should be done. A protection of the mucous membranes using a dental dam is performed.

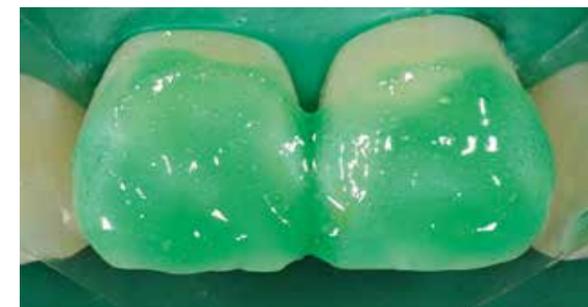
- Icon-Infiltrant can penetrate into porosities in fluorosis white spots and thereby minimizes the difference of refractive index between the health enamel and fluorosis white spots.
- The number of etch times will be decided according to the assessing in Icon-Dry step. When the expected result is not achieved, the white spot need to be etched and dried again before infiltration step.
- Icon infiltration is a promising and micro invasive treatment for the patient impaired by fluorosis white spots.

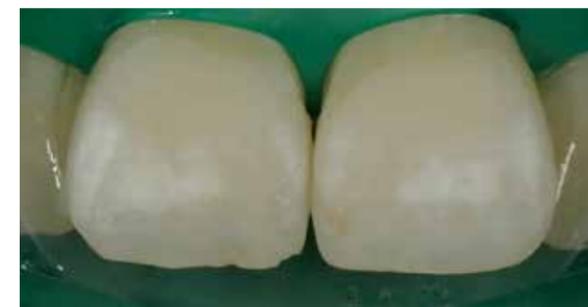
Fig. 4: After each etching procedure, Icon-Dry was used for drying after thoroughly spraying the acid off.

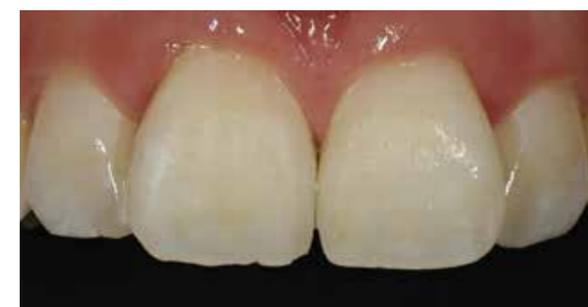
Fig. 6: Results immediately after treatment.

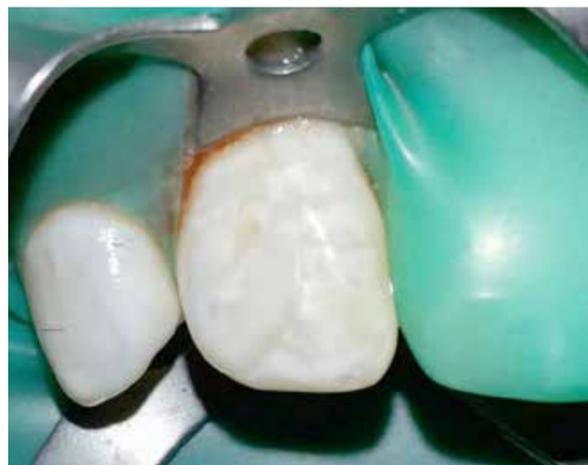
Prof. Dr. Neeraj Gugnani

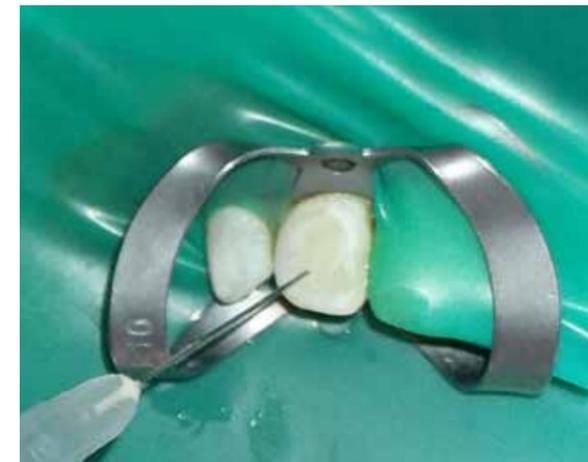
The tooth represented in this clinical case is #12, which was isolated with rubber dam and the white opacity covering the whole tooth is visible in the pre-operative clinical picture (Fig. 1). This was followed by application of Icon-Etch for 2 minutes (Fig. 2).

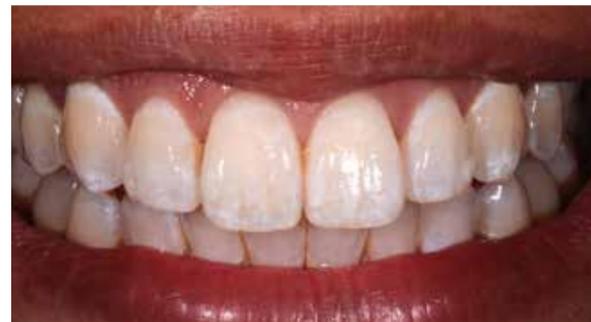
**Fig. 1**  
A 26-year old female patient presenting mild to moderate fluorosis looked for esthetic treatment. Her main complaint regarded the whitish diffuse opacities that affected her smile.

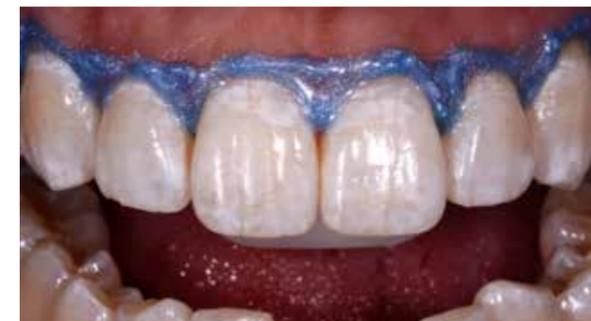
To evaluate the depth of the affected enamel a clinically useful tool is to perform transillumination. Specific equipment or even a simple light curing unit can be positioned on the lingual surface and commanded to emit light. When the transmitted light is not or is only slightly blocked by the opacities, the lesions (enamel porosities) are shallow and the probability of less invasive therapies to be effective is higher. In the present case, this was the situation and the fluorotic lesions were judged shallow, indicating a good prognosis for resin infiltration.

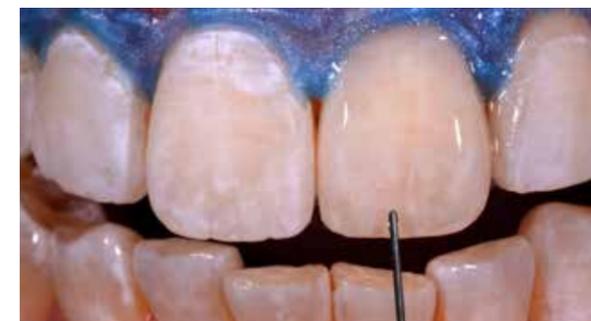
Next step is isolating the teeth that will be infiltrated. Field isolation and protection of the gingival tissue can be obtained using rubber dam or a liquid light-cured resin dam (Top Dam, FGM, Brazil) together with cheeks, lips and tongue retractors. While the liquid dam is usually faster and easier to apply, rubber dam may present a more intense gingival retraction, that may improve results in the cervical area. In this case, the liquid dam was selected and carefully applied to cover as little enamel as possible.

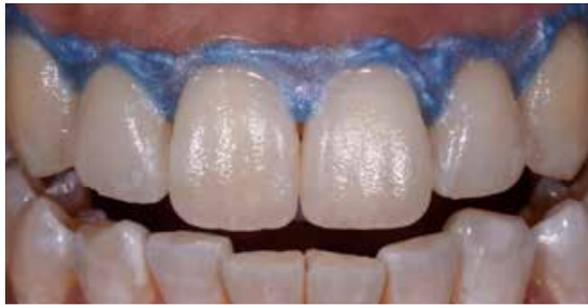
**Fig. 9:** It is possible to see the immediate aspect after infiltrant polymerization. It is normal to observe a shiny and irregular appearance due to excess of the infiltrant covering the surface. This material is easily removed with polishing instruments as abrasive disks, spirals or rubber cups.

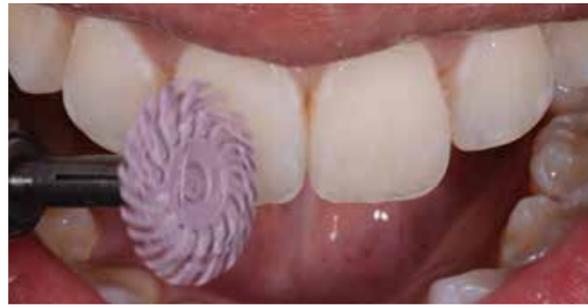
**Fig. 10:** In the present case polishing was performed using disks and spirals (Sof-lex, 3M, USA).

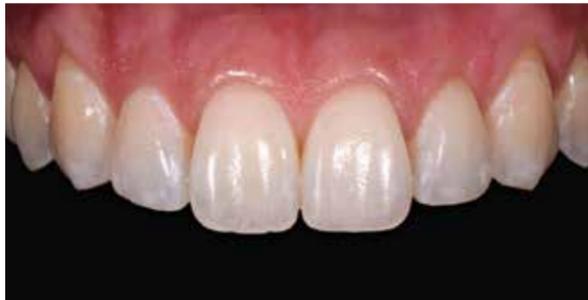
**Fig. 11**  
After polishing, the result of the treatment is shown on Figure 11 and 12. Almost all white opacities disappeared, indicating a satisfactory infiltration of the fluorotic enamel.

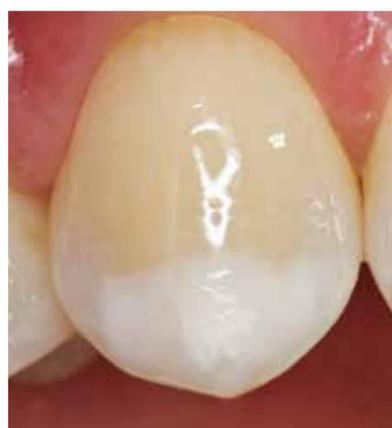
Fig. 1: Initial situation

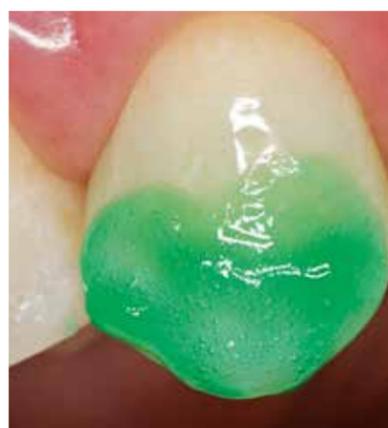
Fig. 2: After cleaning with prophylaxis paste, the affected vestibular area was initially conditioned for 2 minutes with 15% hydrochloric acid gel (Icon-Etch, DMG). At this juncture, the more heavily mineralized surface layer was removed. This shows fewer pores as a result of remineralization processes than the lesion underneath and would thus prevent the infiltrant from penetrating. After 2 minutes, the etching gel was water sprayed off and the lesion carefully dried.

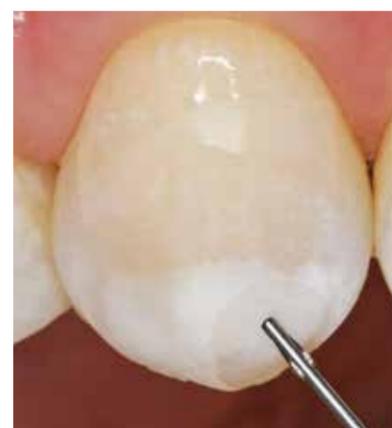
Fig. 3: To achieve further deep drying and at the same time check whether sufficient abrasion of the surface layer was achieved, ethanol (Icon-Dry) was subsequently applied to the lesion. Due to penetration of the ethanol into the lesion's porosities, similar to the later infiltration with resin, the light refraction within the caries was reduced, making the lesion appear less whitish-opaque. When this effect can be observed in the first 2-5 seconds after application of the ethanol, the surface layer is sufficiently abraded to guarantee a quick and complete infiltration.

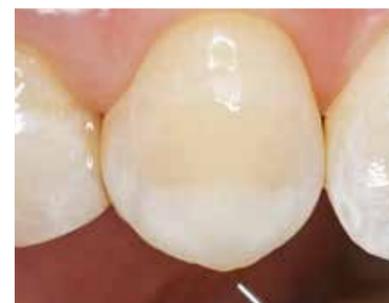
For a better estimate of the esthetic result, the most severely affected tooth (13) was treated first. In the present case, there was no isolation with rubber dam because desiccation and protection of the soft tissue could be guaranteed by an adequate distance to the gingiva.

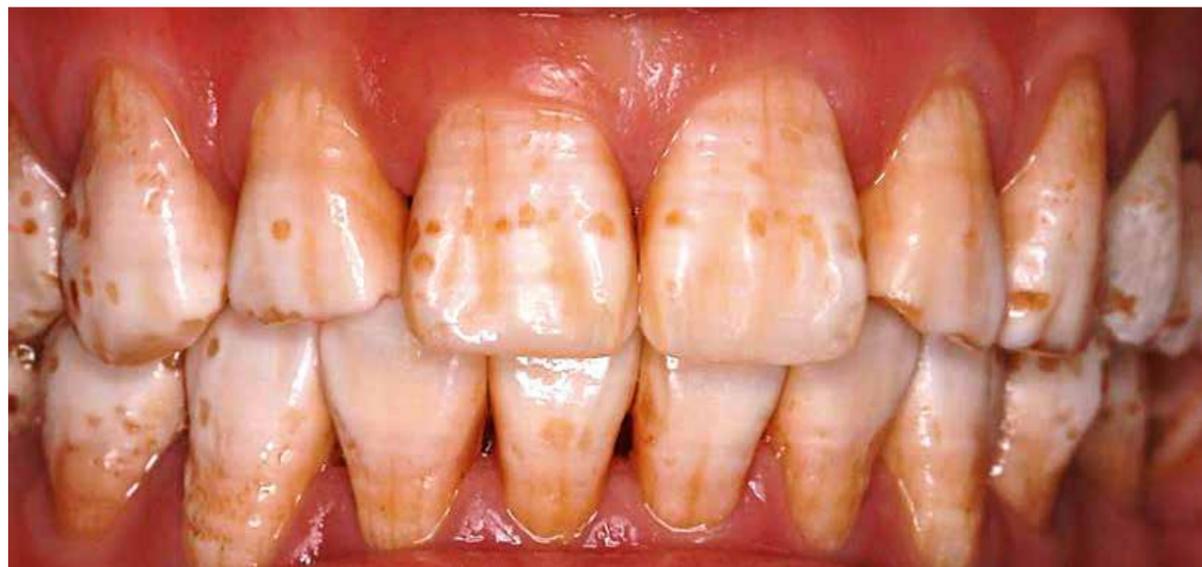
Fig. 1: Before treatment. The full dentition was mottled and defected. We chose at-home bleaching first to improve the color of the teeth.

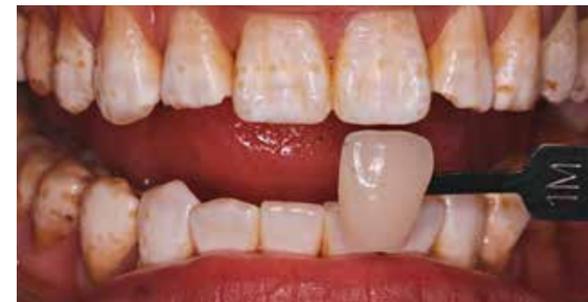
Fig. 2: After the comprehensive clinical examination the colorimetric analysis was done and the color of the teeth was recorded. We made individual bleaching tray for the patient and gave the instructions of at-home bleaching and oral health instruction. After using eight units of Opalescence PF 10 % for four weeks, the color of teeth improved dramatically. We began the Icon resin infiltration treatment.

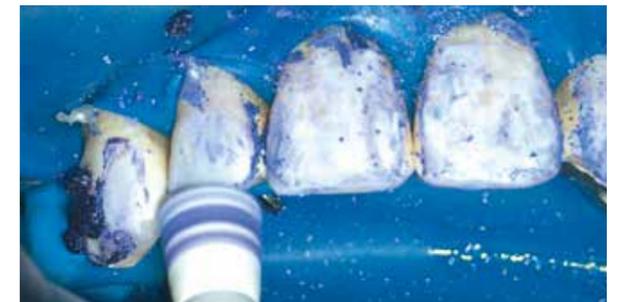
Fig. 3: The use of rubber dam is essential when Icon is applied. After cleaning the teeth, rubber dam was performed to isolate the operative site from the rest of the mouth. Tooth cervix was tied off with dental floss. Applied Opalustre grinding paste, which is 6.6 % hydrochloric acid slurry that contains silicon carbide microparticles, on the tooth surface. Polish for 60 s with low speed dental handpiece and rubber cup under the middle pressure. Rinse the grinding paste and evaluate the effect.

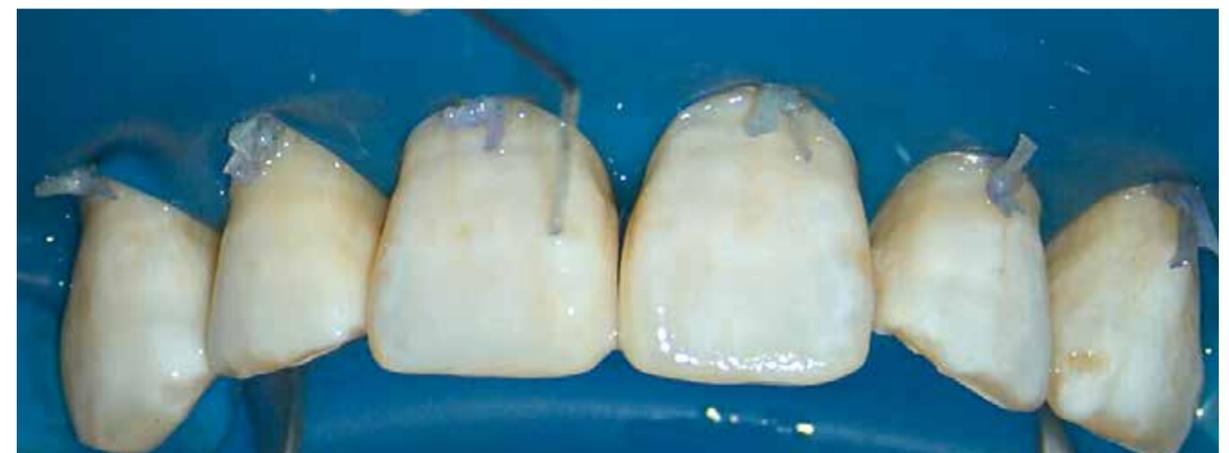
Fig. 5: Screw the application tip onto the Icon-Dry syringe, apply an ample amount of material onto the lesion, and allow to set for 30 s. In this step a preview of the final result is shown. When wetted with Icon-Dry, the whitish-opaque coloration on the etched enamel should diminish. The result of the visual check after the first etching showed that the second etching is necessary.

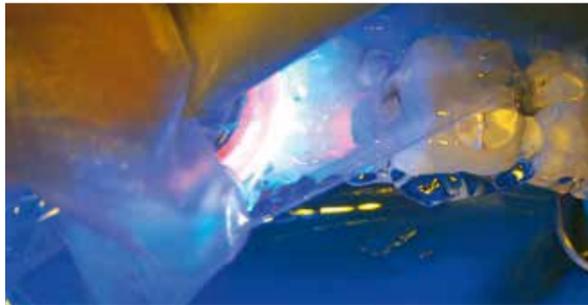
Fig. 8: Use ENA HRI esthetic restorative system (UD3+UE3) to fill enamel defects.

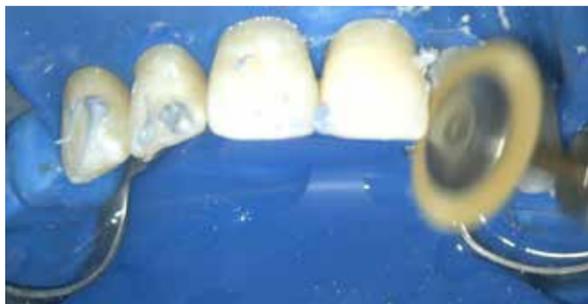
Fig. 10: Polish the teeth surface with wool polishing wheel and ENA SHINY A,B,C paste.

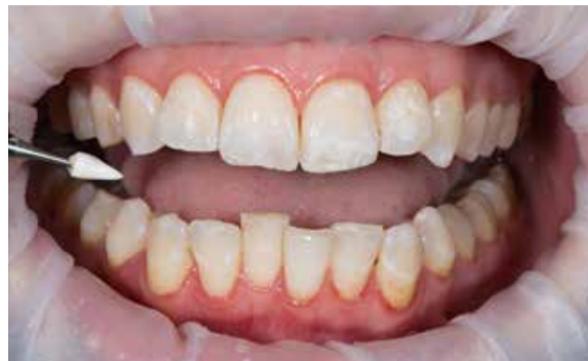
**Fig. 1:** Start by applying an opragate to get the patients lips out of the way. Then take a white polishing stone and gently polish the enamel surface for a few seconds to get rid of the superficial biofilm on the enamel surface.

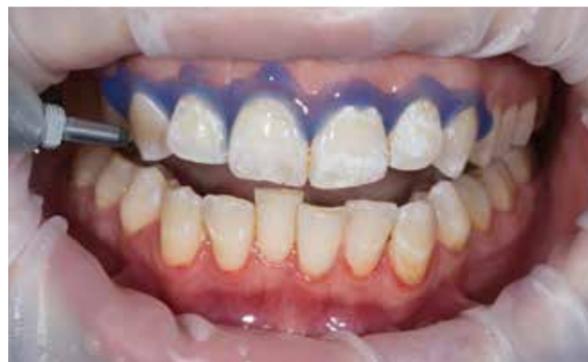
**Fig. 3:** Blast the white spots with white aluminiumoxide. This will enable better access to the body of the lesion. Blasting of the white lesions should only be done for 2-3 seconds and only once, with the blasting tip positioned approximately 1 cm from the enamel. After completion of this stage the white lesion should give away a matte appearance.

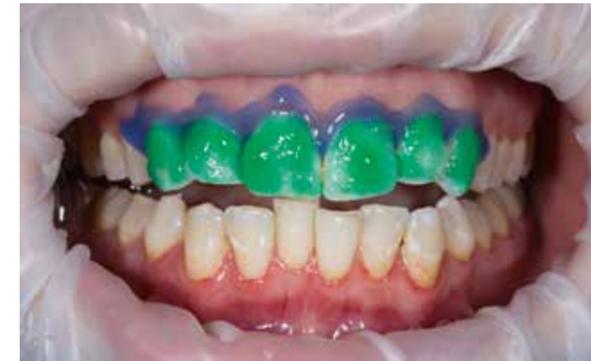
**Fig. 4:** Apply Icon-Etch over the white lesions and rub it gently for a few seconds with a dry tip until the etch loses its glide and gives away a foamy appearance. Let the Icon-Etch rest on the surface for 2 minutes and then rinse it off with water for at least 30 seconds.

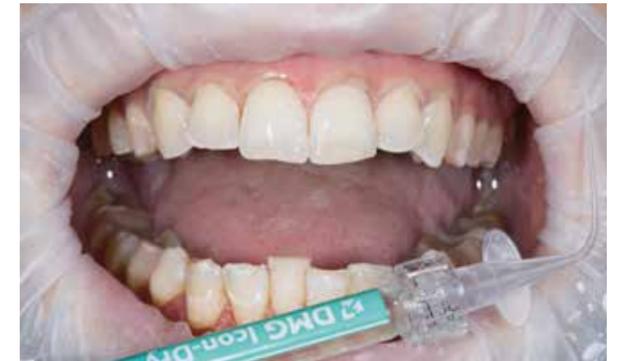
**Fig. 5:** After careful rinse of the tooth surface, dry with oil-free and water-free air. Then wet the white lesion with Icon-Dry. What you want to see is either a complete temporary masking/disappearance of the white lesion when wetted or a fluctuation in the white color of the lesion when wetted with Icon-Dry. This indicates that the lesion is now accessible for the Icon-Infiltrant.

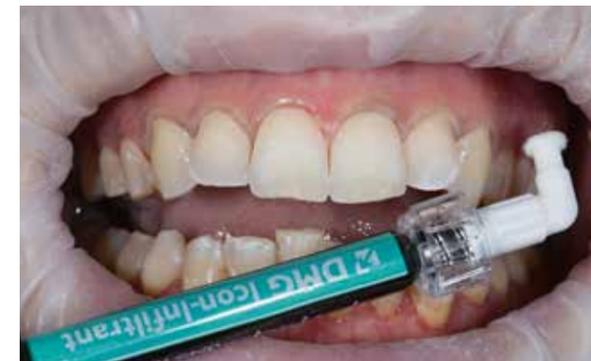
**Fig. 6:** When the white lesion has responded well to Icon-Dry it is time to use the Icon-Infiltrant. Take your chair attached lamp away from the patient's teeth and apply Icon-Infiltrant on a dry enamel surface. Use rich amounts. Let it then infiltrate the surface for 3 minutes. Carefully air-dry the surface followed by flossing then light cure for 40 seconds. Repeat the process a second time, but with only 1 minute infiltration time.

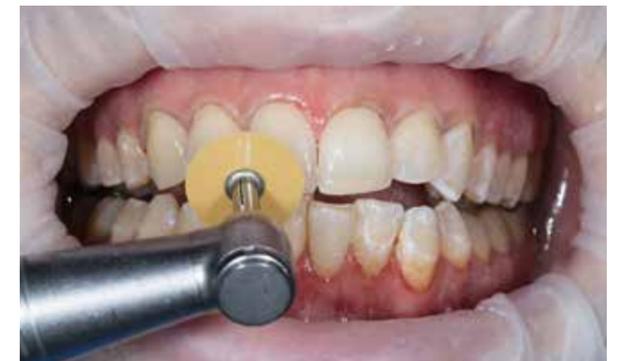
**Fig. 7:** After the Icon-Infiltration process the enamel surface will present a matte appearance. To get a shiny and smooth surface use 3M polishing discs. Start with a light orange disc on a dry surface and carefully polish away any unevenness. Moreover, rinse the surface with water, air blast and finish the polishing process by using a yellow disc.

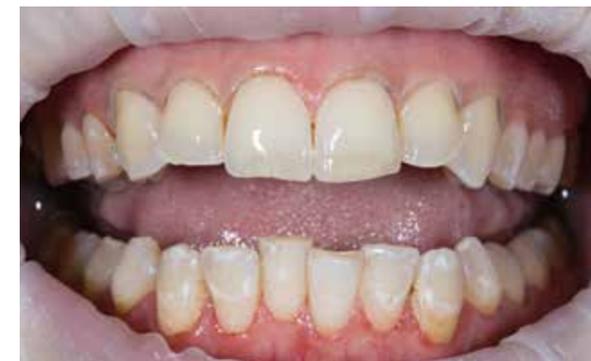
**Fig. 8:** Final result.

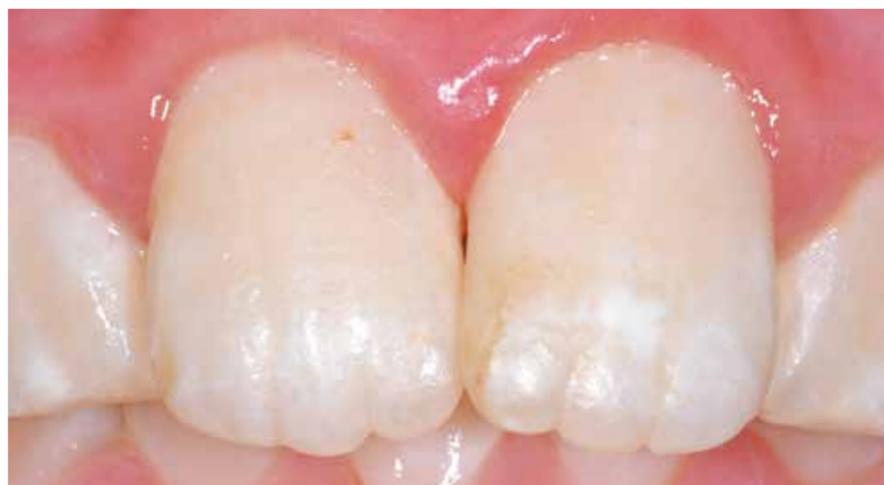
Fig. 1: Initial situation of the fluorotic spots before treatment with Icon. Especially the appearance of the teeth 21 and 11 were esthetically compromising.

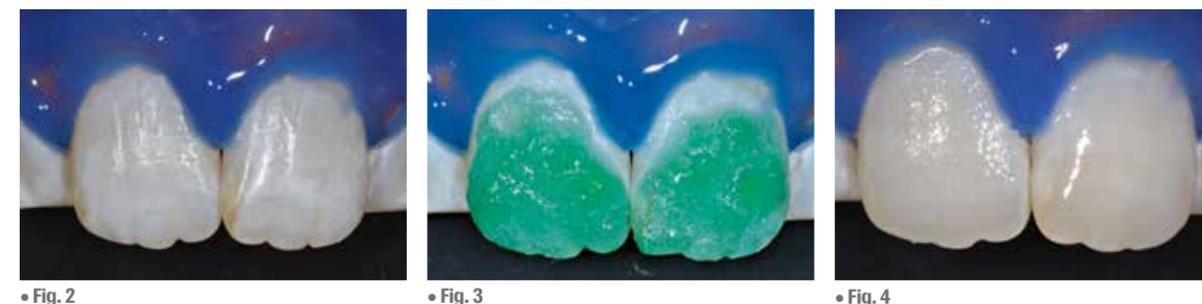
• Fig. 2: After polishing the teeth with pumice the resin barrier Opaldam Green (Ultradent®) was applied in order to isolate the working field and to protect the gingiva which both is mandatory when using Icon. • Fig. 3: To condition the surface Icon-Etch was applied for 2 minutes. The etching gel was removed with water spray for 30 seconds and the surface was dried. The etching step was repeated 4 times. Especially with fluorosis it is often necessary to repeat the etching step several times to gain sufficient access to the lesion body. • Fig. 4: In the next treatment step Icon-Dry was applied for 30 seconds. Immediately after the wetting with Icon-Dry the operator gets a preview of the masking effect. If the lesions do not diminish the etching step should be repeated. After 30 seconds the surfaces were thoroughly dried with oil free and water-free air.

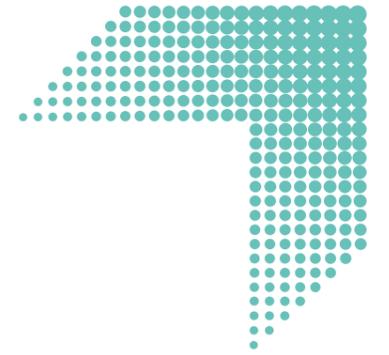
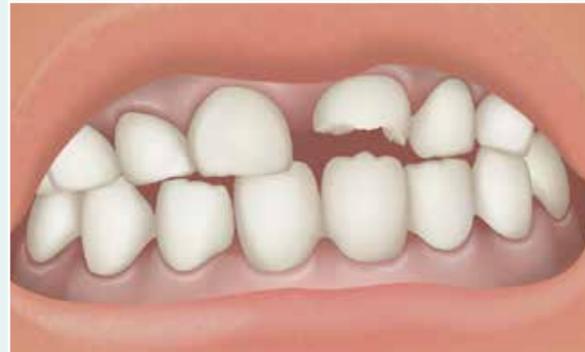
**Patient history or etiology.** A trauma or apical periodontitis in the primary tooth.

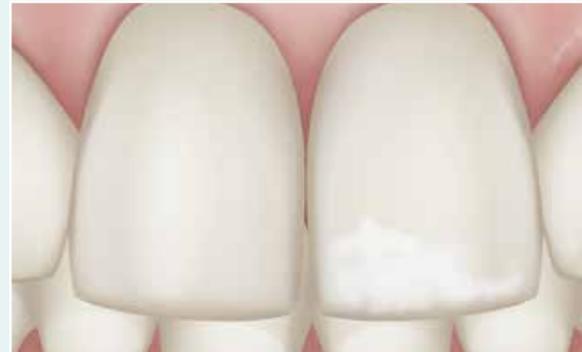
**Affected tooth/teeth.** Usually one or several teeth. Associated lesions can often be found on opposite jaw.

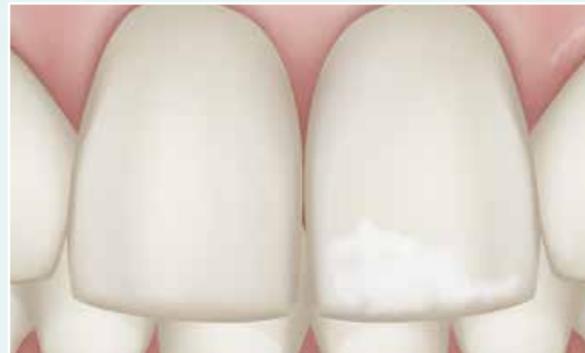
**Localization.** Mostly affects the facial surface (the side closer to the lips or cheek).

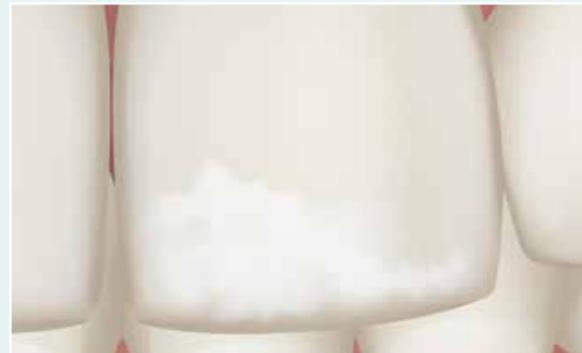
**Border. Well-demarcated.** It also could be a quantitative defect associated with reduced localized thickness of enamel (enamel hypoplasia).

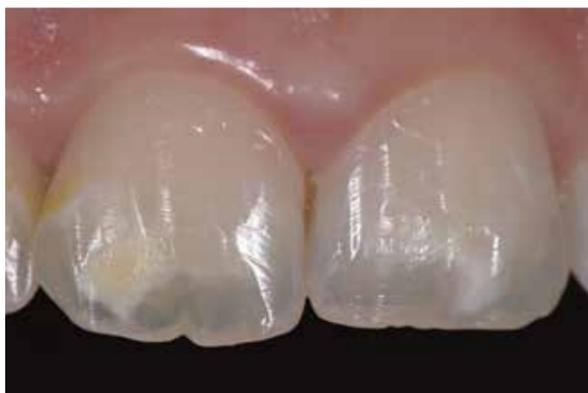
**Fig. 1:** Initial situation with two lesions due to trauma on teeth 11 and 21 (white lesion on 21 and slightly yellow on 11). The third incisal portion of teeth is concerned with a high translucency of the edge. As the lesion appears relatively deep, we know that we need to infiltrate in depth. So we eliminate a very thin layer of enamel with the bur.

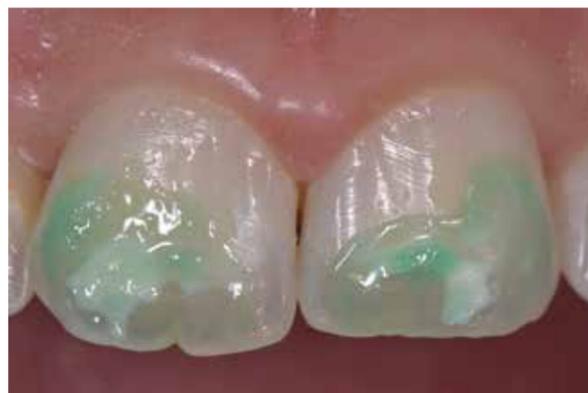
**Fig. 2:** First application of Icon-Etch.

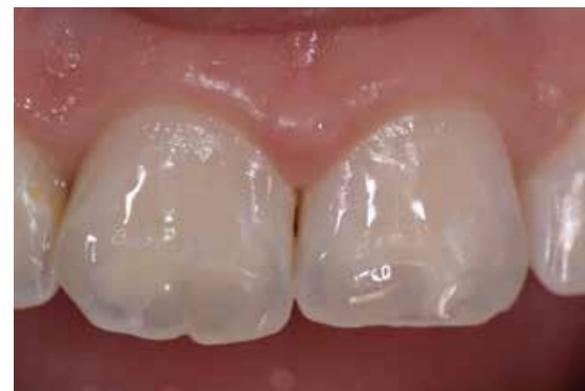
**Fig. 3:** After rinsing, drying and application of Icon-Dry, we note a slight masking of the lesions. But not enough to infiltrate.

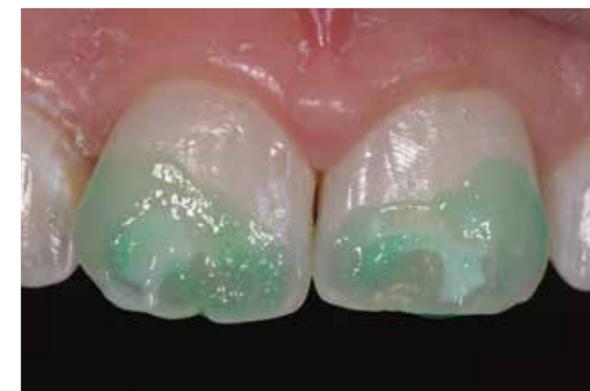
**Fig. 4:** Second application of Icon-Etch.

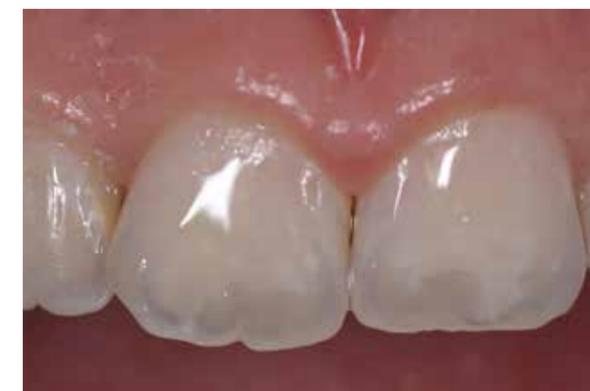
**Fig. 6:** Icon-Dry allows a partial masking of the lesion. That shows that ethanol can infiltrate the porous lesion. We know that Icon-Infiltrant could infiltrate too.

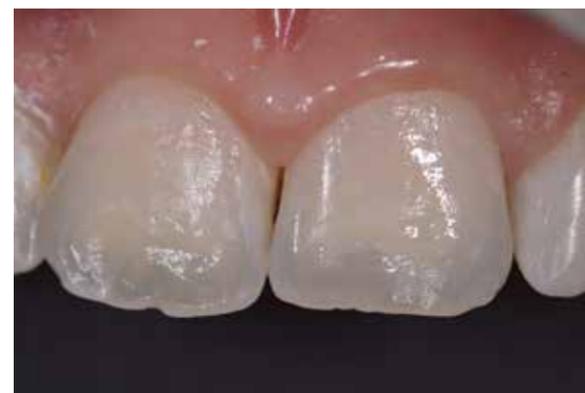
**Fig. 7:** After infiltration with Icon-Infiltrant and light curing. The masking is efficient.

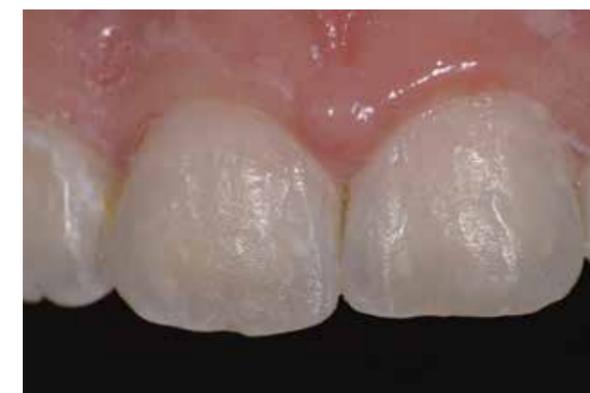
**Fig. 8:** A small amount of enamel composite is sufficient to compensate the very small loss of substance of enamel due to the combination of bur and acid erosion. The lesions are not visible anymore.

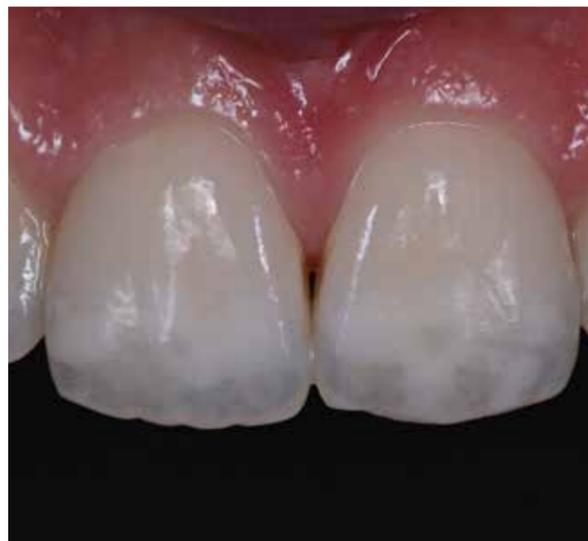
Fig. 1: Initial situation. With a black background the contrast gets better, but the white spots are still not clear. Britt is dissatisfied with the white spots on teeth 12, 11 and 21.

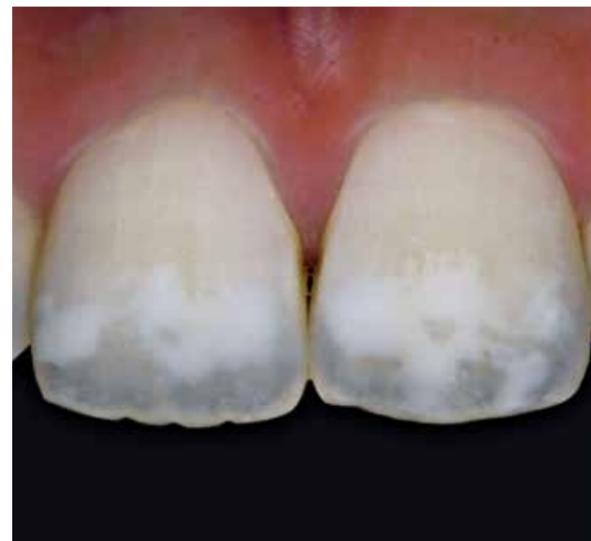
Fig. 2: A cross-polarised photo with high colour intensity of the initial situation. In a sudden the white spots are clearly visible.

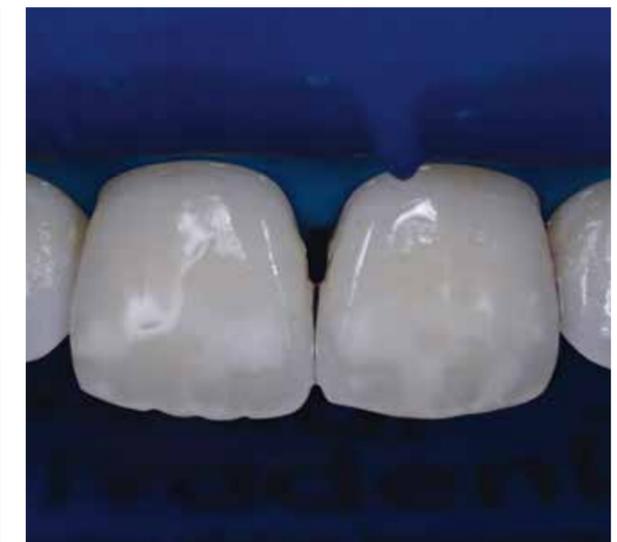
Fig. 6: Application of 99 % ethanol (Icon-Dry, DMG) shows the patency to the porosities. One more etching procedure was performed after this result.

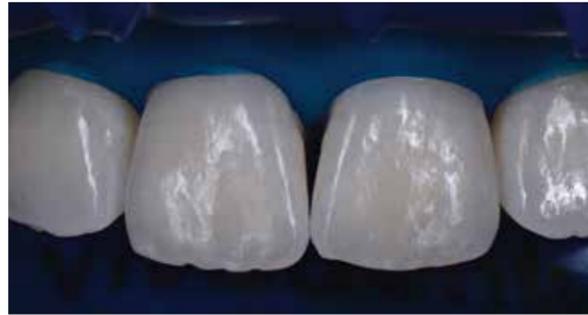
Fig. 8: Situation after polishing with rubbers (Brownie and Greenie, Shofu) and felt disc with aluminium oxide (Flexibuff with Enamelize, Cosmedent).
