A winning  
**smile?**

**Yes  
Please!**

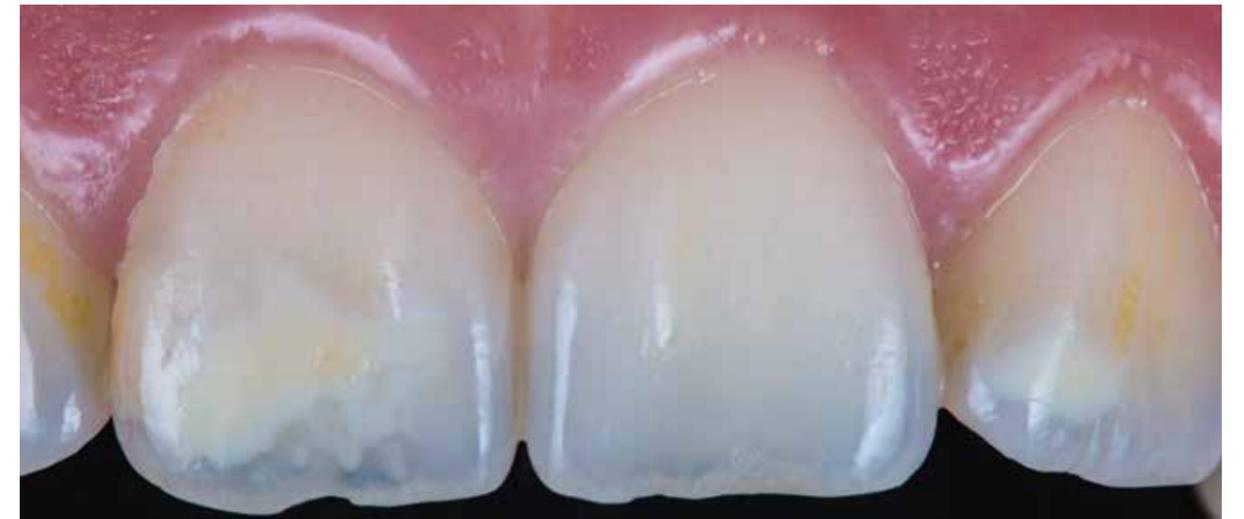
Fig. 1: Initial situation with large white spots on the incisal half of 11 and 22. Patient experienced trauma on primary incisors at the age of 4. The history, shape, location, asymmetry and absence of similar lesions on the other teeth indicate the diagnosis of post traumatic white spots. The opaquer areas of the white spots indicate deeper parts of the lesion that will require a deeper treatment.

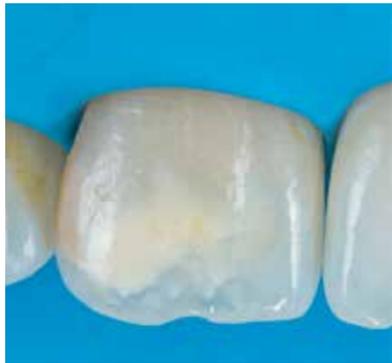
lesion is usually close to a well mineralized enamel surface layer

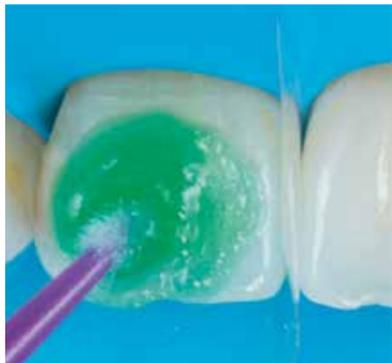
Fig. 3: The depth of the lesions indicates a thicker well-mineralized surface layer that needs more than just acid erosion in order to access the body of the lesion for infiltration. To accelerate the process and reach good final result, a red ring bur is delicately used on the surface layer prior to the acid. Fig. 4: Prior to each etching step, the surface layer is sandblasted as well as the healthy enamel surrounding the white spots to optimize the result and limit the »edge effect« due to an insufficient infiltration of the margin of the lesion.

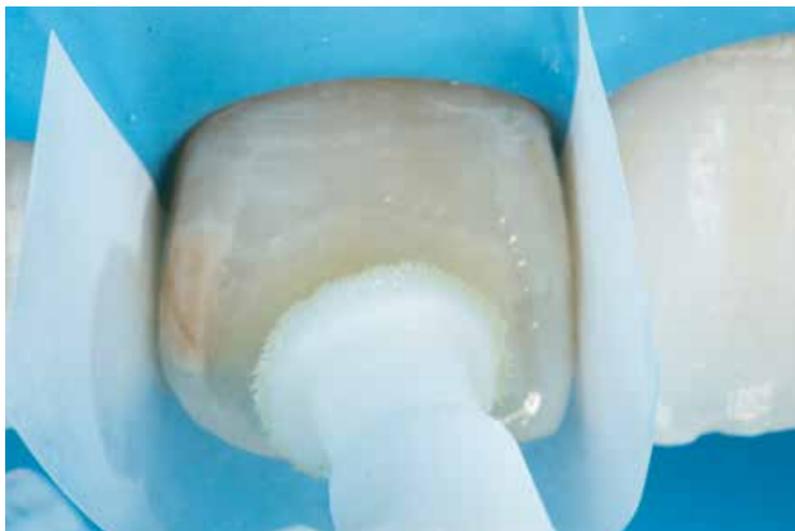
Fig. 6 and 7: After several steps alternating mechanical and chemical erosion, the use of Icon-Dry finally shows a satisfied result with a dramatical masking of the white lesions.

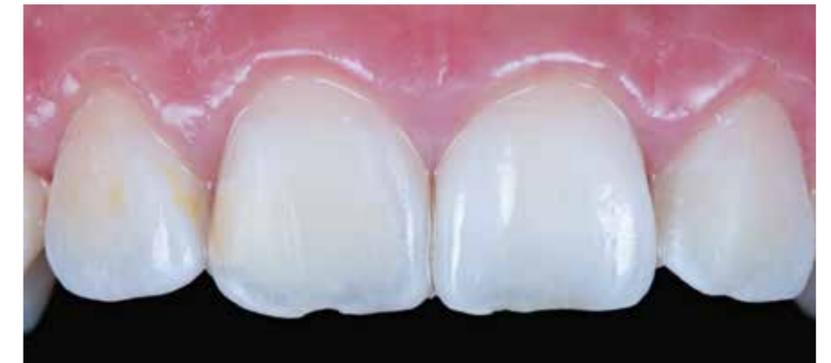
Fig. 11: Final situation one year after the treatment show an amazing stability of the infiltration result.

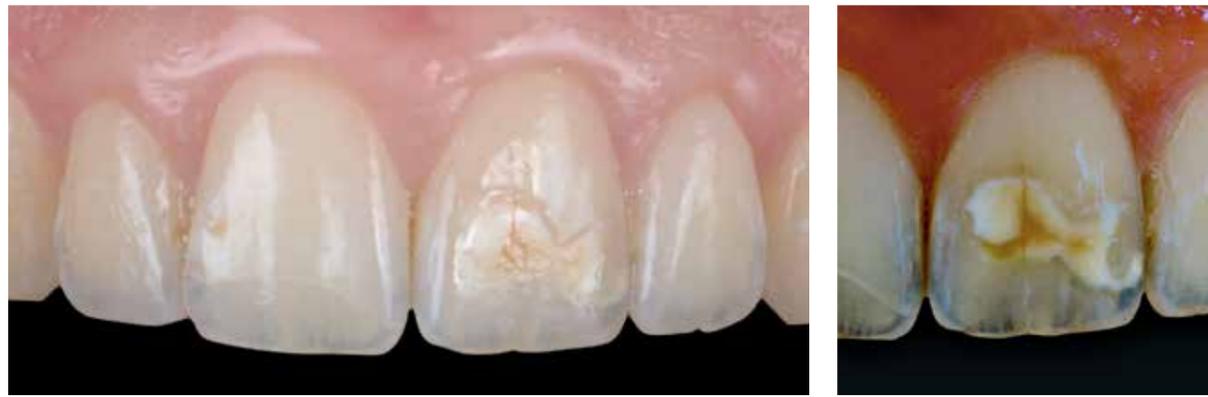
Fig. 1-2: Initial intra oral picture and initial polarized picture.

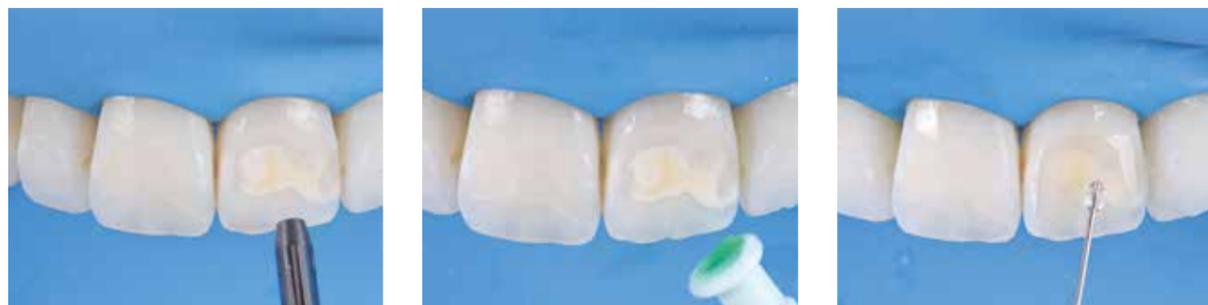
Fig. 3-5: First step after Isolation with rubber dam placement is a prophylactic polishing. The deep cycle protocol is then : sandblasting with alumine oxyde 27 microns (Fig. 3). Erosion with Icon-Etch (15% HCl) 2 minutes (Fig. 4) Desiccation with Icon-Dry (application of alcohol) (Fig. 5). At this step we have to control if the spot is always present. If yes, a second same cycle is necessary [3].

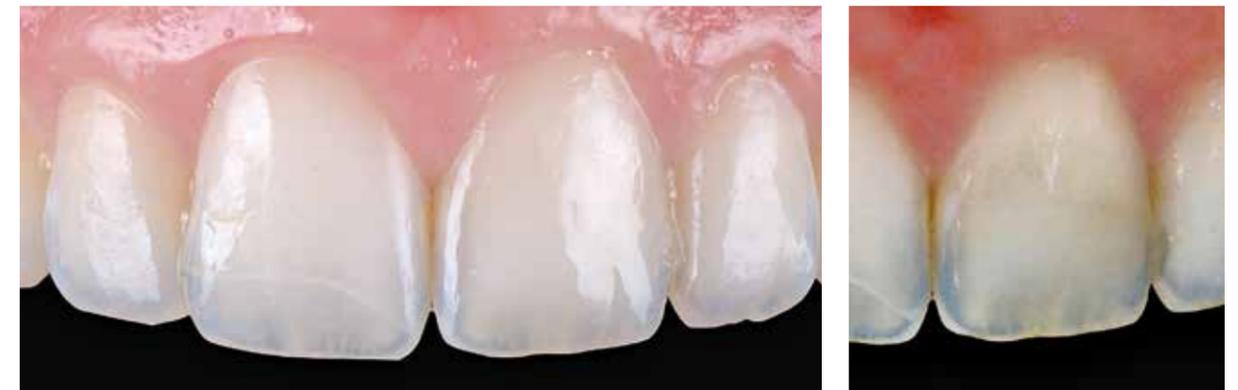
Fig. 9: Final intra oral picture. After two months the result is satisfactory. The beauty of this internal dentin stratification has been conserved!

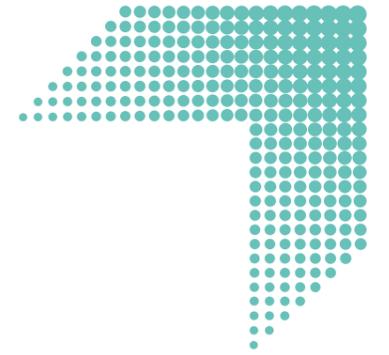
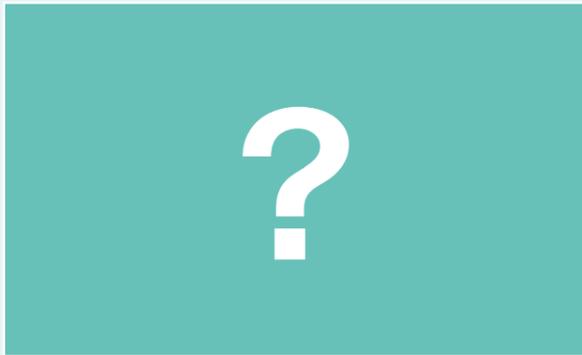
**Patient history or etiology.** Unknown, non specific.

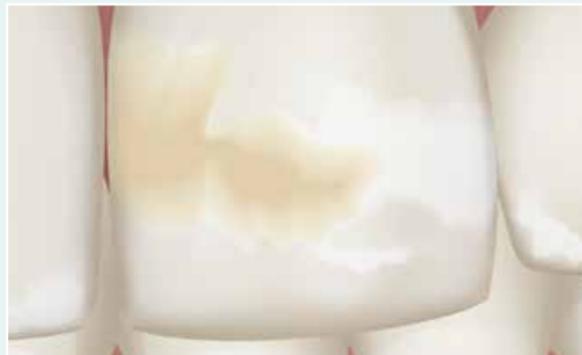
**Border.** Well-demarcated, a qualitative defect affecting enamel translucency. No changes to the enamel thickness.

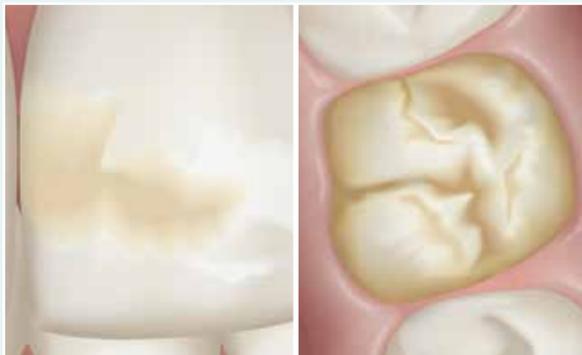
**Color.** Whitish-cream or yellow-brown. The intact enamel surface is hard, smooth and often hypermineralised following posteruptive maturation, the subsurface enamel is soft and porous [3,4].

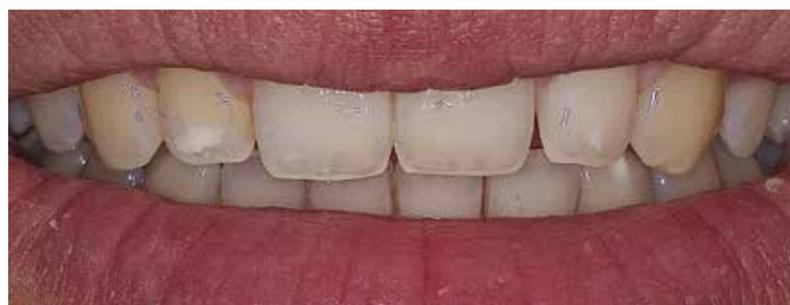
Fig. 1: Initial view of a lesion on the upper right lateral incisor.

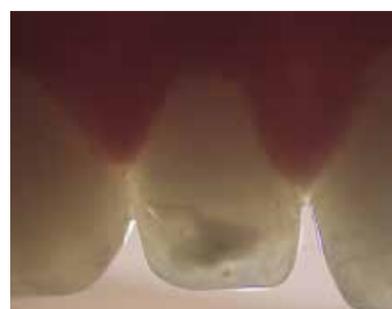
This classification regroups three major types of enamel opacities: Superficial, mixed and deep lesions. Each category has specific clinical features in relation with the topography of the lesion and the proper treatment approach will be then adopted accordingly. While keeping in mind that superficial lesions represent the easiest category to achieve a favorable treatment outcome, the idea behind the treatment concept proposed implies the transformation of mixed and deep lesions into superficial ones using abrasive procedures before proceeding with their infiltration [2]. This clinical case report describes a suggested treatment of a deep lesion affecting a lateral maxillary incisor related to MIH based on transillumination, focalization and lesion transformation to achieve a good aesthetic result.

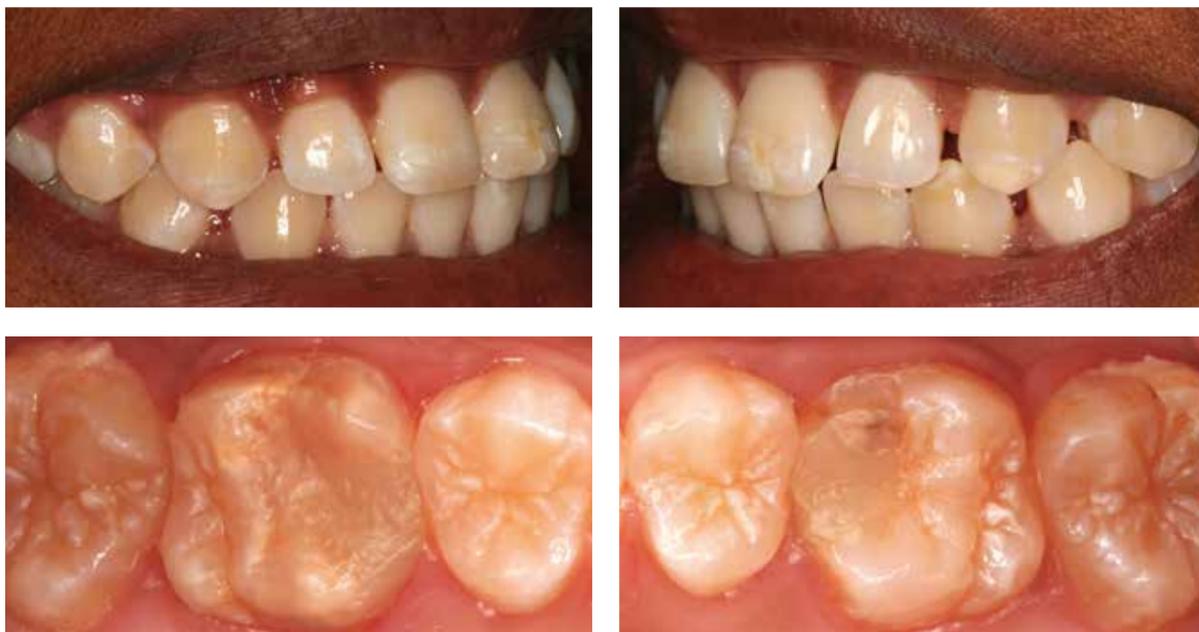
Fig. 1: Patient with main lesions in upper incisors, left canine and first upper molars, characterizing MIH. The lesions on mesial surface of molars were already restored with composite

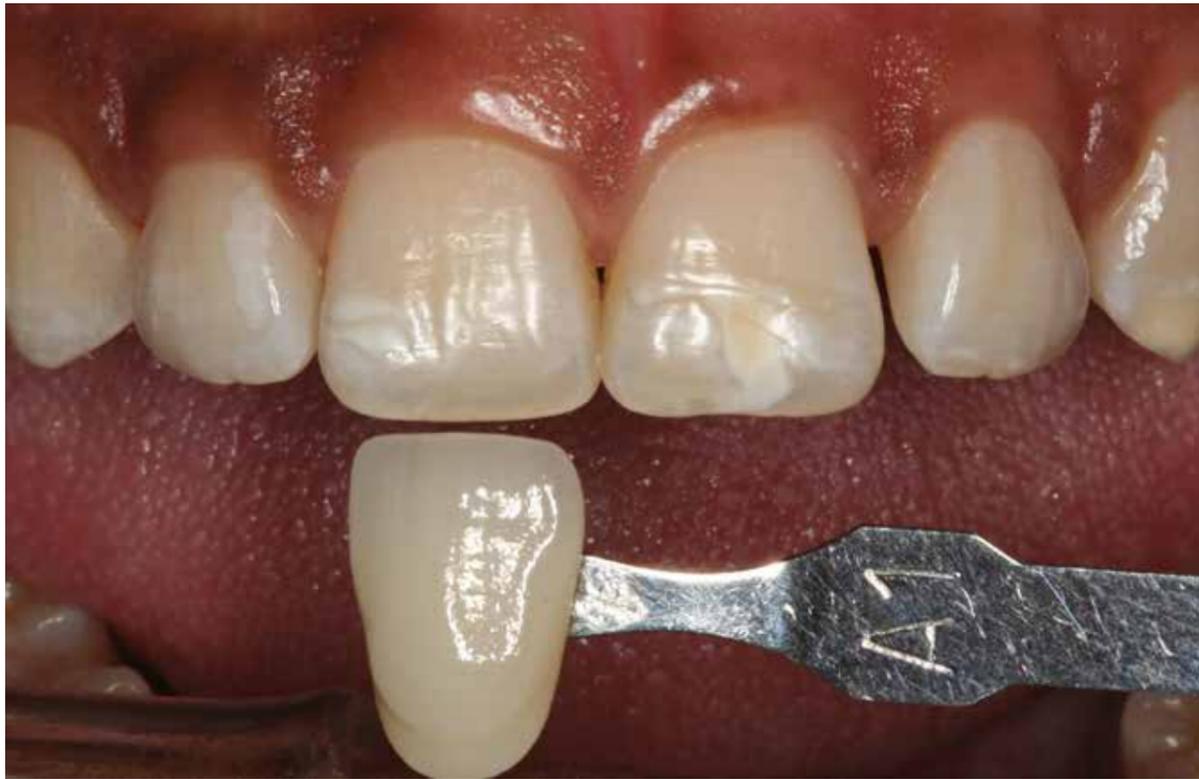
Fig. 3: As a composite would be necessary to cover the deep infiltrated area, the shade selection was performed as the first step.

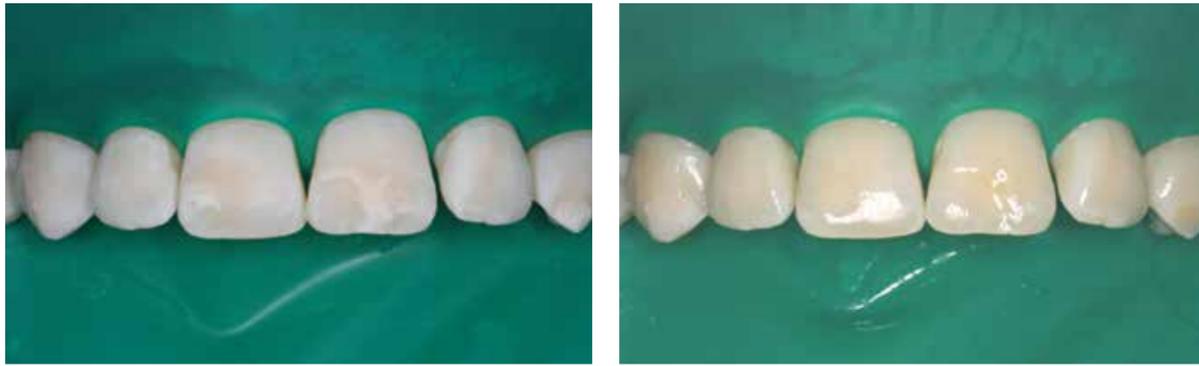
**Fig. 7 A-B:** After that, the surface was dried with air and the resinous infiltrant (Icon-Infiltrant, DMG) was applied over the labial surface of all teeth, remaining undisturbed for 3 min. The excess was removed with an air stream and the light-curing was performed during 40 s on each tooth. Then the infiltrant was applied again and let over the surface for 1 minute. The excess was removed and the light-curing was performed.

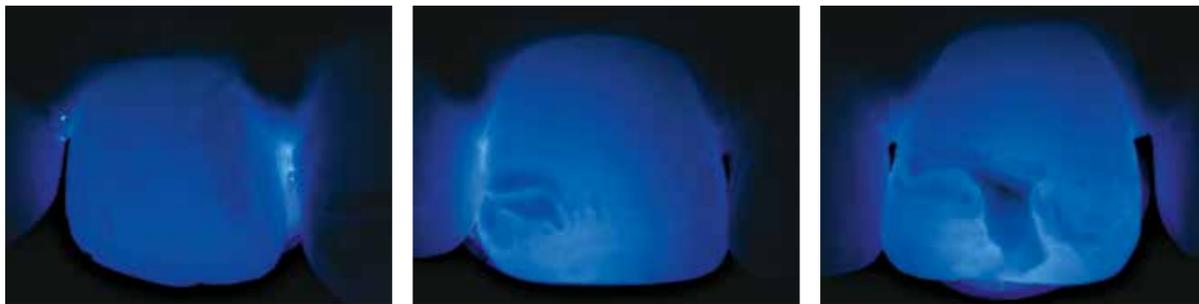
**Fig. 8 A-F:** The transillumination procedure was repeated after the infiltration, showing a significant increase in the light transmission. The dark areas of the deep lesion in the left central incisor became lighter (Fig. 8 C and 8 F), while the lesion in the right lateral incisor became even more translucent than at the baseline (Fig. 8 A and 8 D).

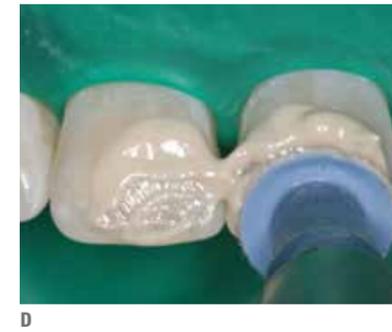
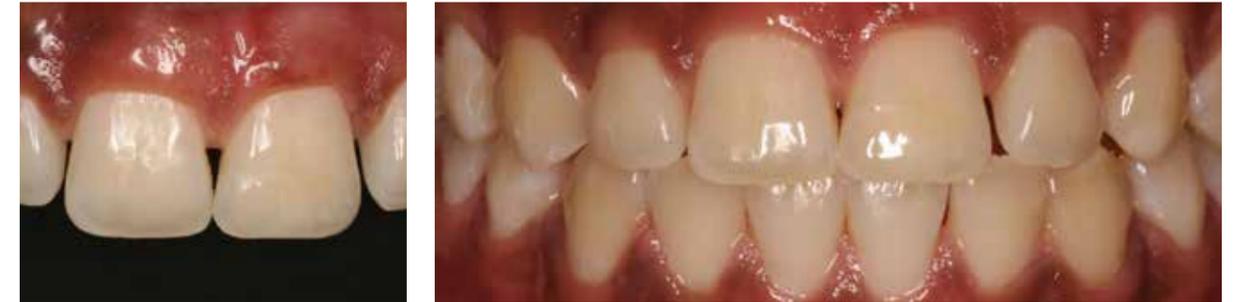
**Fig. 10 A-B:** Post-treatment results.

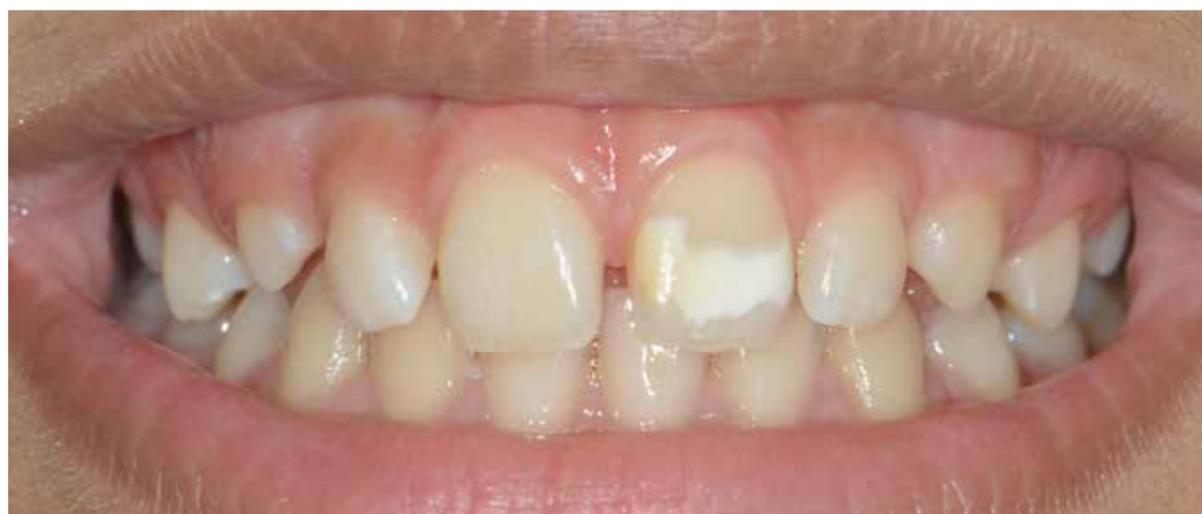
Fig. 1: Initial aspect of the lesion.

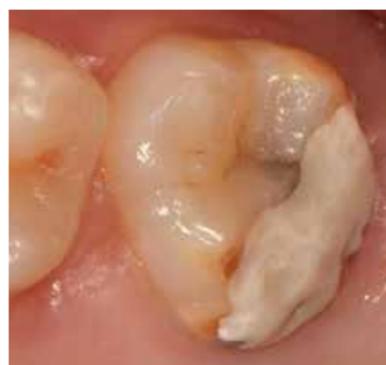
Fig. 2: Hypomineralization in the maxillary molar associated with MIH.

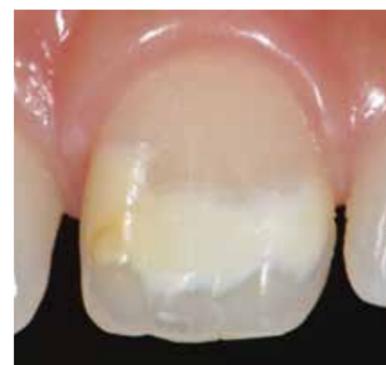
Fig. 3: Closer view of the white-yellow lesion in the enamel.

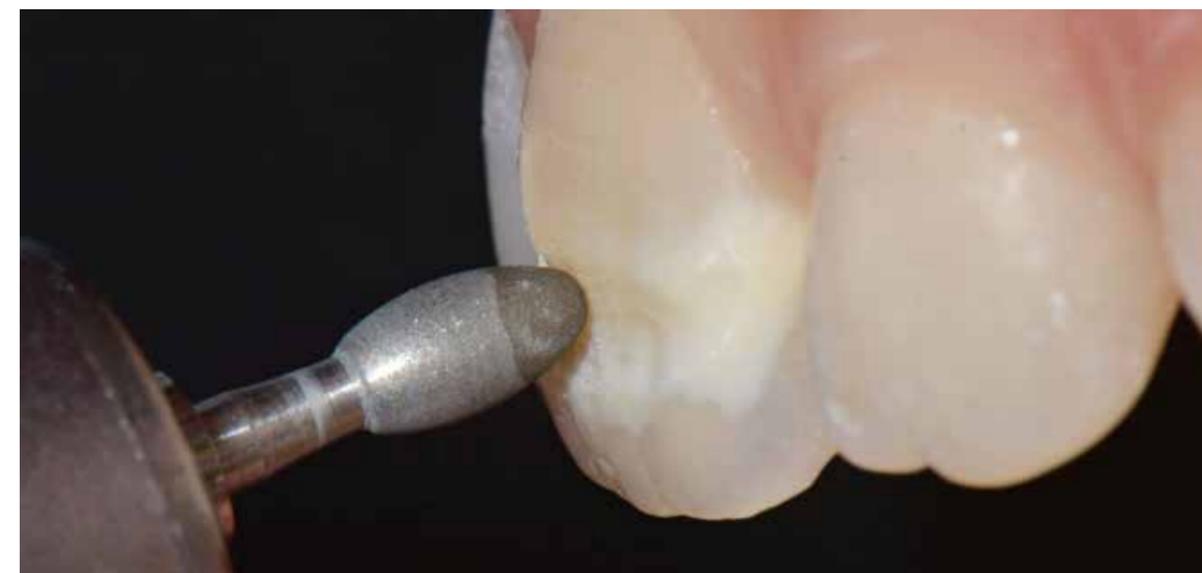
Fig. 4: In the first step, prophylaxis was performed and the labial surface of the affected enamel was slightly prepared with a diamond bur to expose the top surface of the lesion and allow the access of the resin infiltrant inside the affected region.

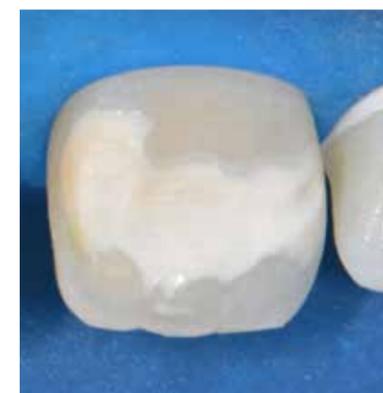
Fig. 5: After partial removal of affected enamel, (note that the discolored inner enamel remains), resin infiltration technique was performed using Icon-Infiltrant for smooth surfaces kit (DMG, Hamburg, Germany). The rubber dam isolation was applied.

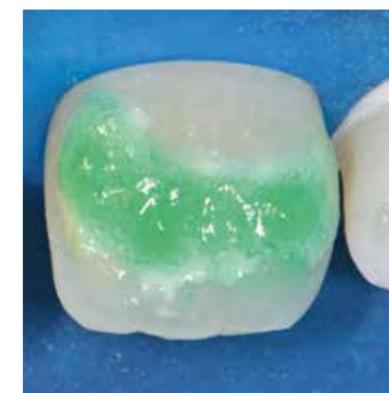
Fig. 6: The surface was eroded with 15% HCl gel (Icon-Etch) for 2 minutes. After that, the acid was fully washed with air/water spray and dried.

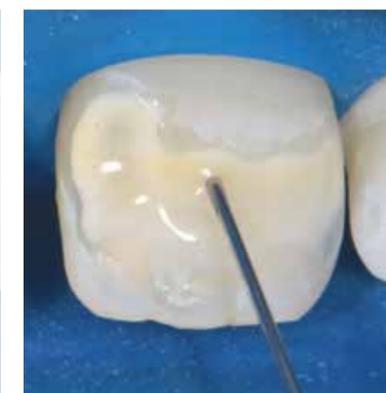
Fig. 7: In order to completely remove water from microporosities, the lesion surface received the application of 99% ethanol (Icon-Dry) for 30 s, and again air-dried. After Icon-Dry application, when the lesion becomes invisible or is reduced in intensity, that means the etched lesion is ready to be properly infiltrated. When no change happens, the preparation can be extended in depth, and/or a new etching step is performed, until some masking with Icon-Dry is observed. The total depth of enamel removal in this clinical case was about 0.5 mm, and the acid was applied for 6 minutes (3 applications of 2 minutes). This progressive preparation is made to allow the minimal invasive intervention as possible.

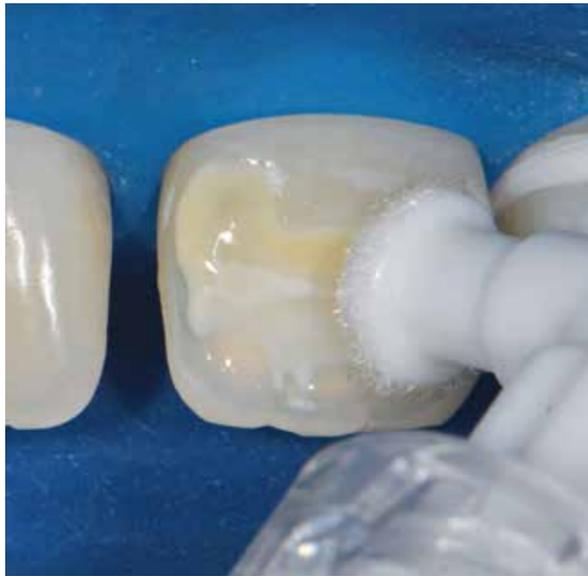
**Fig. 8:** Finally, the Icon-Infiltrant was applied in two steps. The first application was performed for 5 minutes, with surface protected from ambient light with an opaque screen.

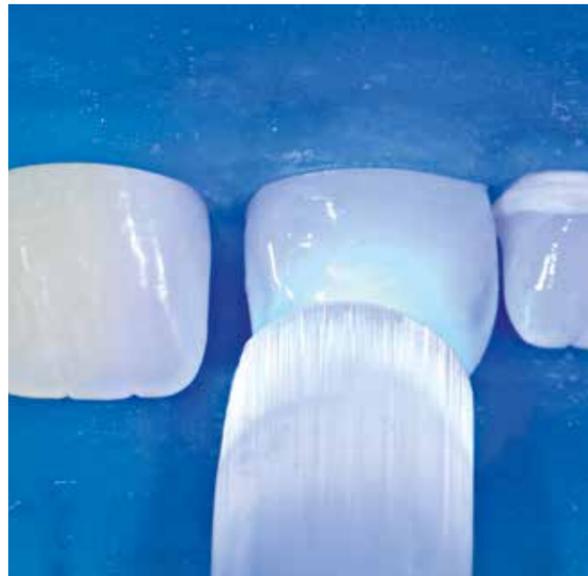
**Fig. 9:** Then excess was removed from the surface with a blow of air, and light curing was performed for 40 s. The infiltrant was applied a second time, for 1 minute, and again light cured for 40 s.

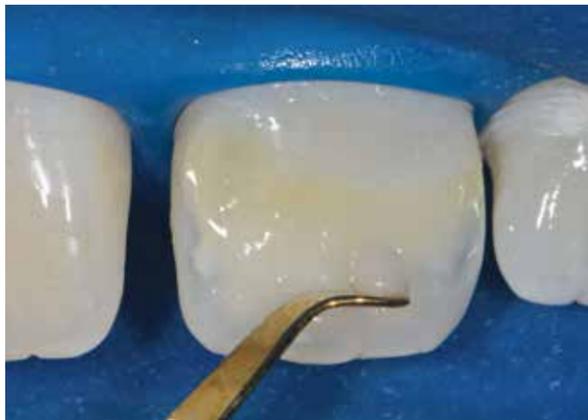
**Fig. 10:** Then, composite resin was applied (Filtek XTE Supreme, 3M ESPE, St Paul, MN, USA) in increments. No separated bonding agent was applied, since the Icon-Infiltrant per se is able to promoted adhesion to the tooth structure [23]. Each increment was light cured for 40 s. Finishing and polishing procedures were performed (Soflex discs, 3M ESPE).

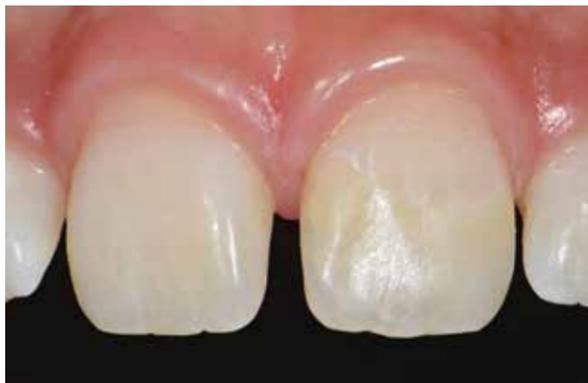
**Fig. 11:** Immediate outcome of the teeth in closer look.

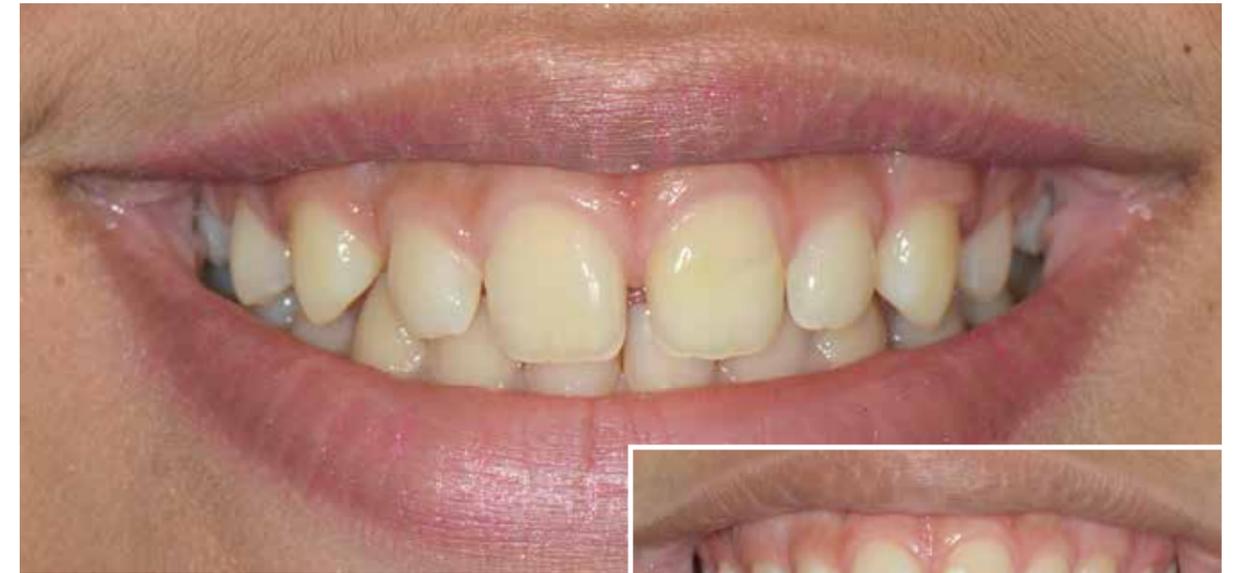
**Fig. 12:** Final outcome after one month.
