## Fabricating direct temporaries with bis-acrylates

**Dr. Murad A. Muradov**

Central Research Institute of Dentistry (CNIIS), Moscow, Russia

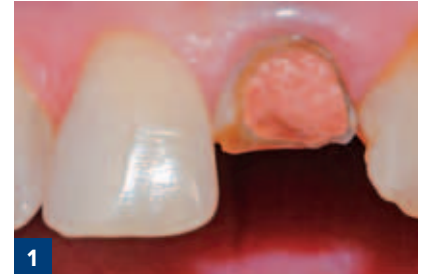
The initial findings reveal a badly damaged dental crown on tooth 21 (fig. 1). Following the core build-up, the tooth is prepared (fig. 2). In order to prevent bleeding of the gums and to obtain an exact reproduction of the preparation line, a retraction chord was placed (fig. 3). If composites are used as core build-up materials the prepared tooth and the surrounding teeth are lightly wetted with Vaseline (fig. 4). On the gypsum model, on which a wax-up of the deteriorated tooth 21 was made, a silicone impression for the temporary is taken with Silagum-Putty Fast (DMG, Hamburg, Germany) (fig. 5).

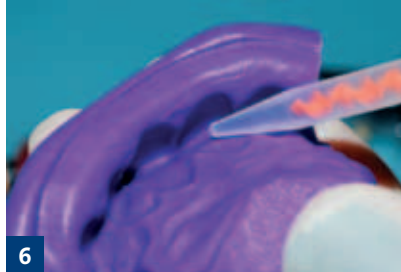
The impression is filled slowly with Luxatemp-Fluorescence (DMG, Hamburg, Germany) to avoid air bubbles. During the process the tip must always be submerged in the material (fig. 6). Silagum-Putty Fast is placed onto the prepared tooth and the adjacent teeth (fig. 7). The impression is then taken out of the mouth (fig. 8). The temporary is taken off the core, excess material is removed and the crown margin is trimmed with a carbide burr.
